Site Visit Report

Church of The Immaculate Conception Tredegar

February 2015

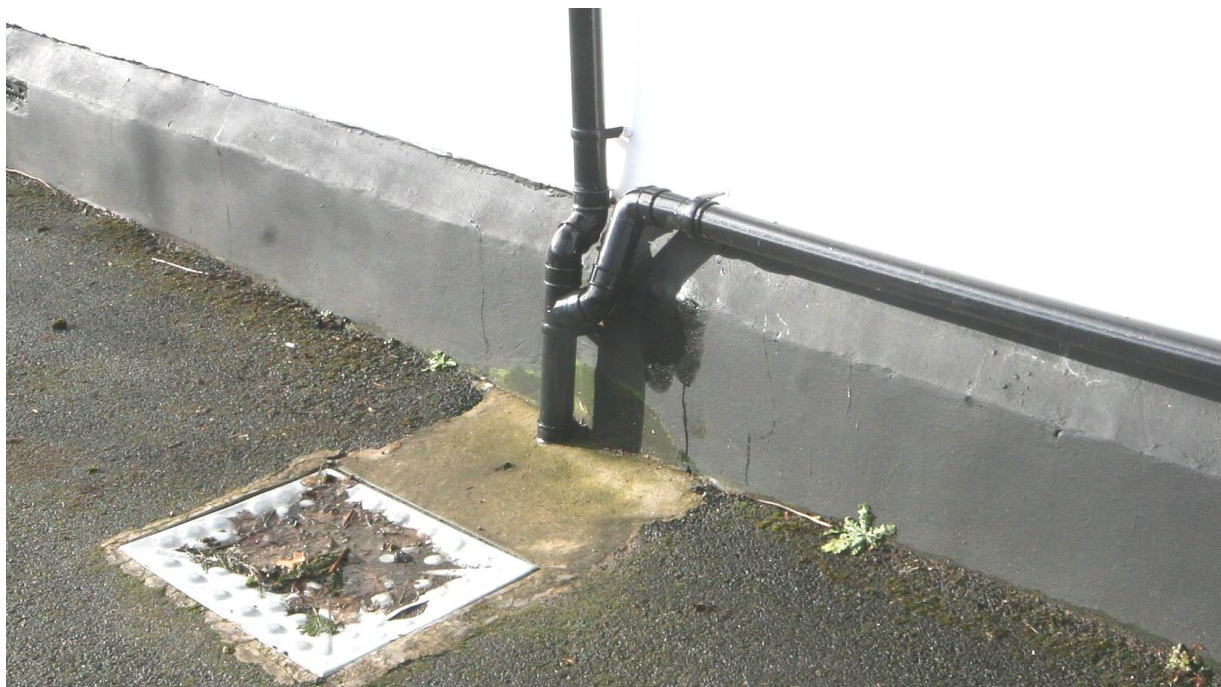
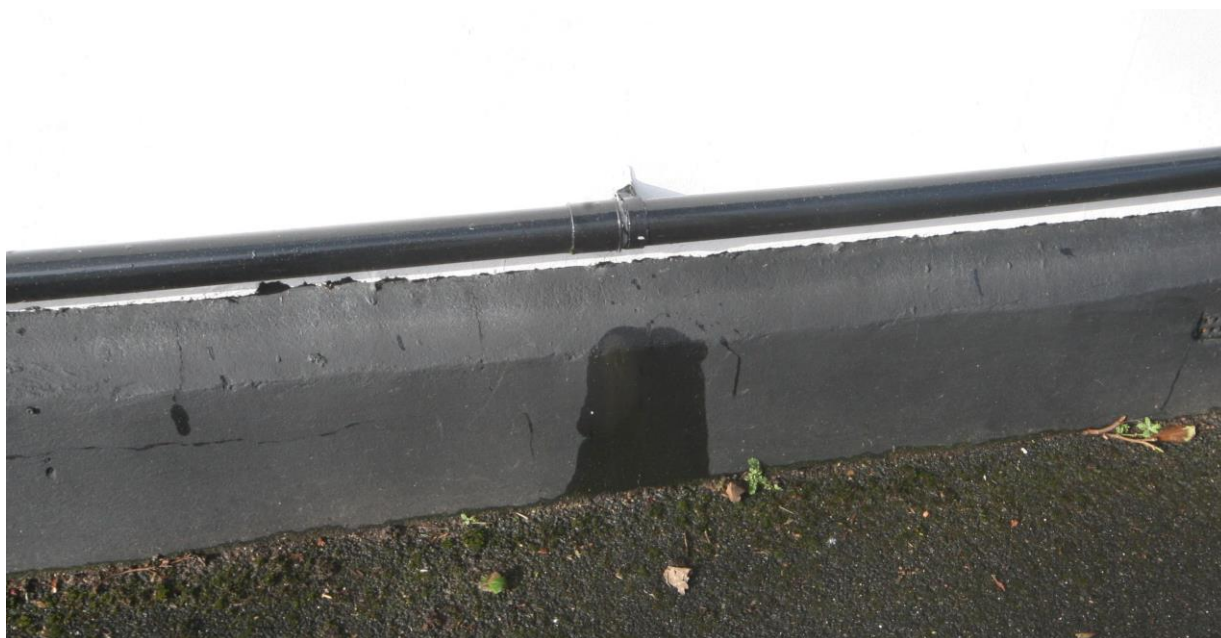
Two dislodged downpipe connections which should be repaired/renewed.

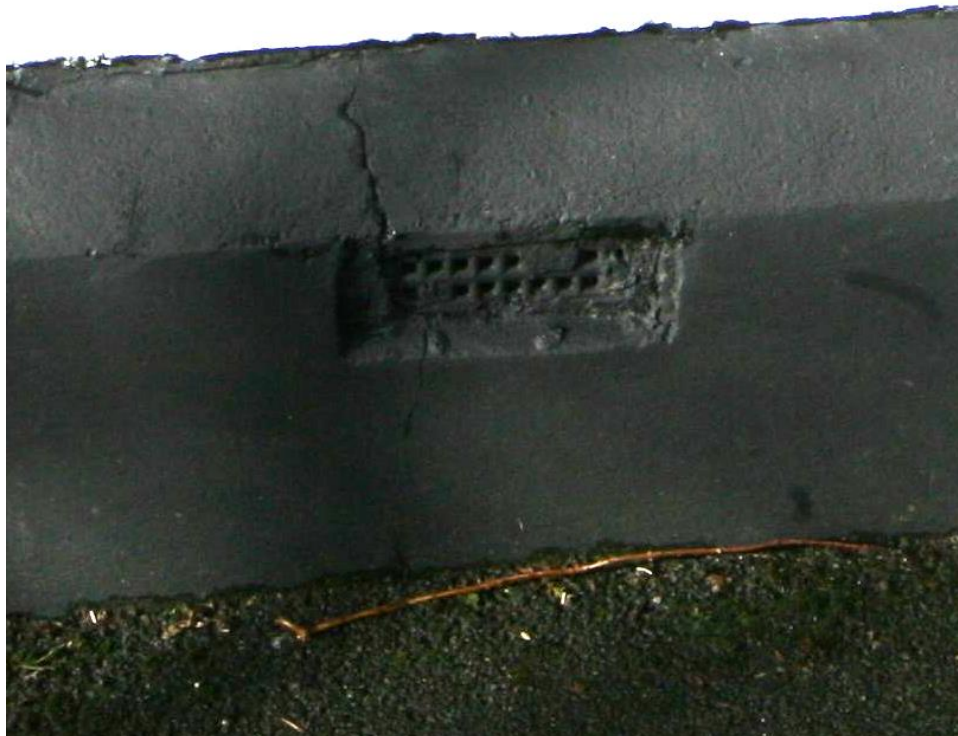
Vents in the plinth should be opened up and maintained

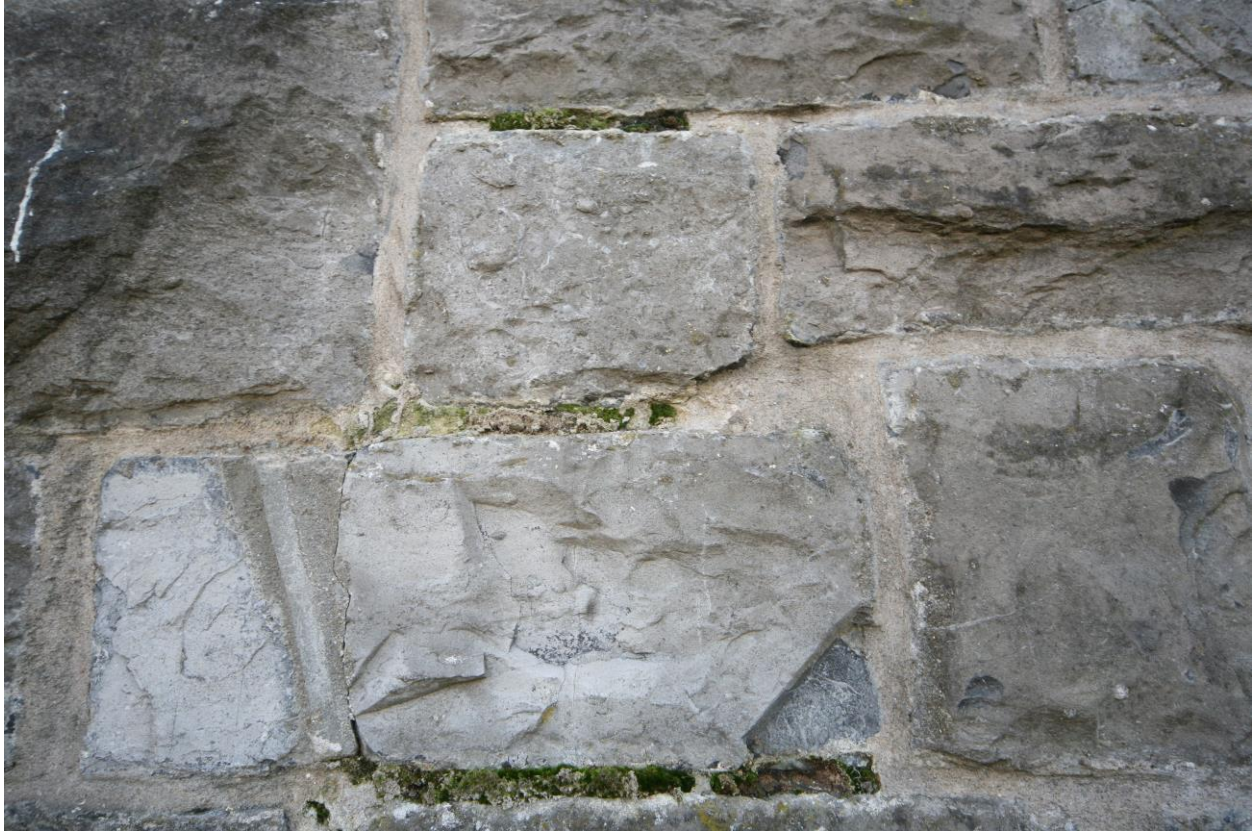
An example where isolated repointing would be sensible – the areas with moss are obviously holding moisture. The cement should be raked out, the wall allowed to dry, then be repointed with Blaenavon aggregate and NHL3.5 lime at 3:1 aggregate to lime. The pointing should be done slightly proud of the surface then tamped back flush with a churn brush.

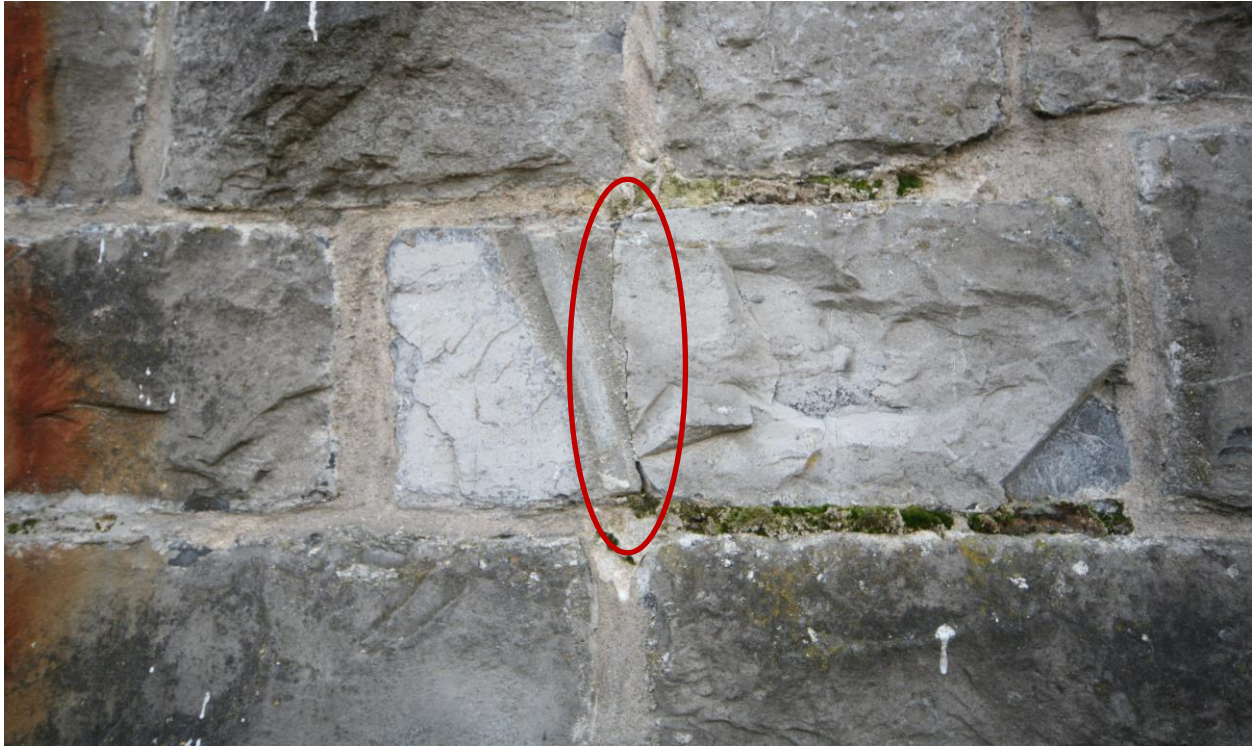
An example of a joint opening up which can allow moisture ingress even if the crack is only hairline. This should be raked out and repaired in lime mortar.

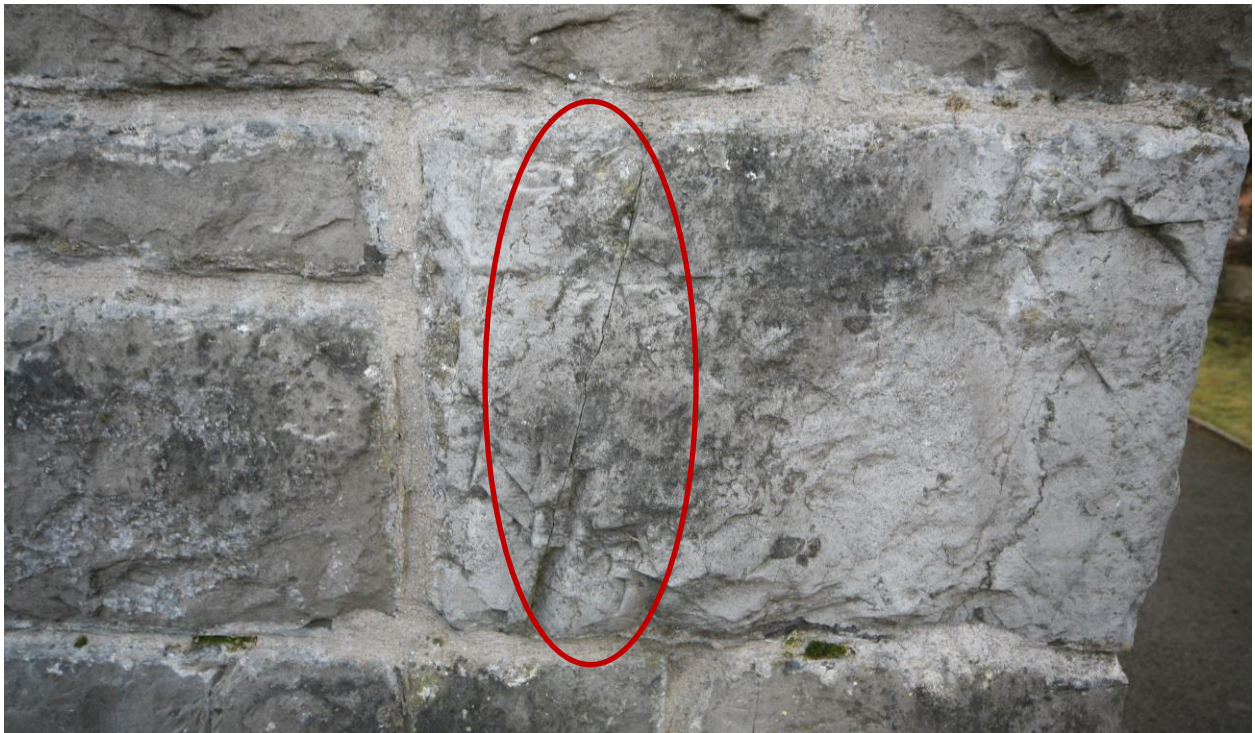
Small hairline fissures in the stones can potentially draw moisture through

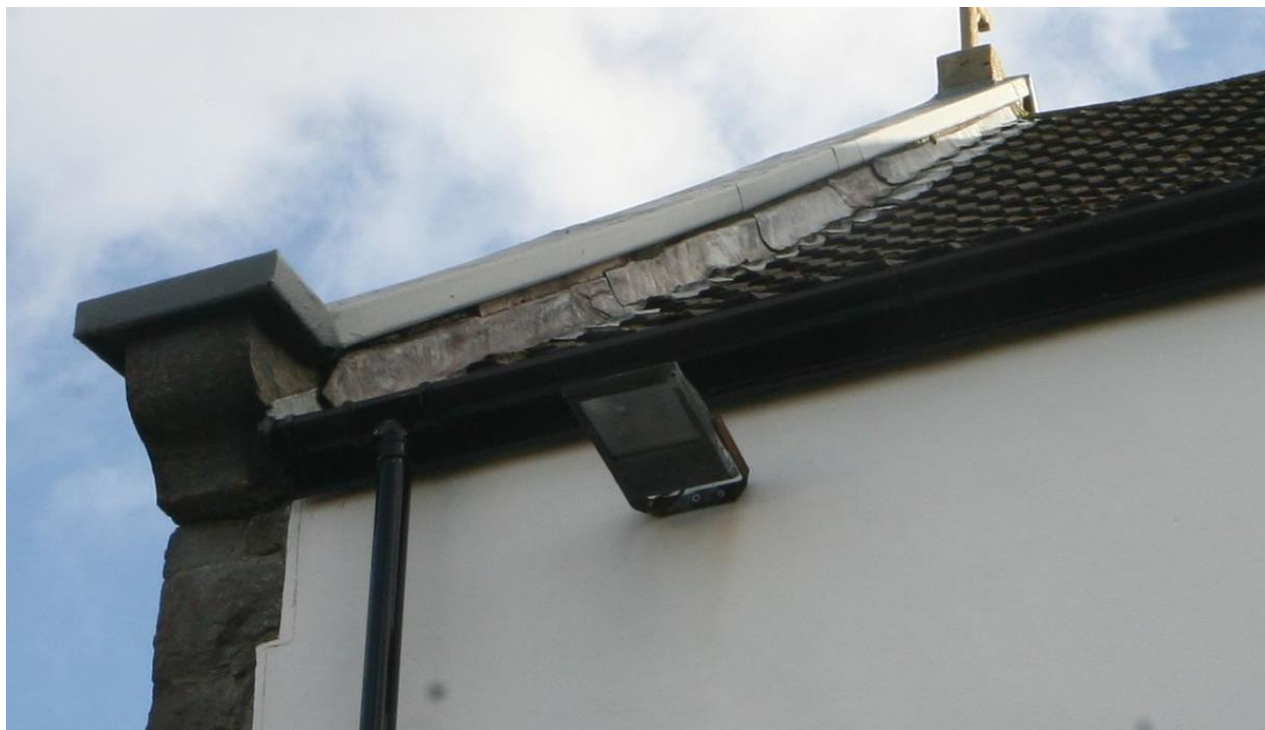
It is important that the mortar fillet between the lead and coping is intact and not allowing water through – any damaged mortar fillets can be replaced with a well fibred sand and lime mix or in this protected location fine hemp plaster. The lead flashings should be checked to ensure they remain intact and are suitably installed and of the correct code.

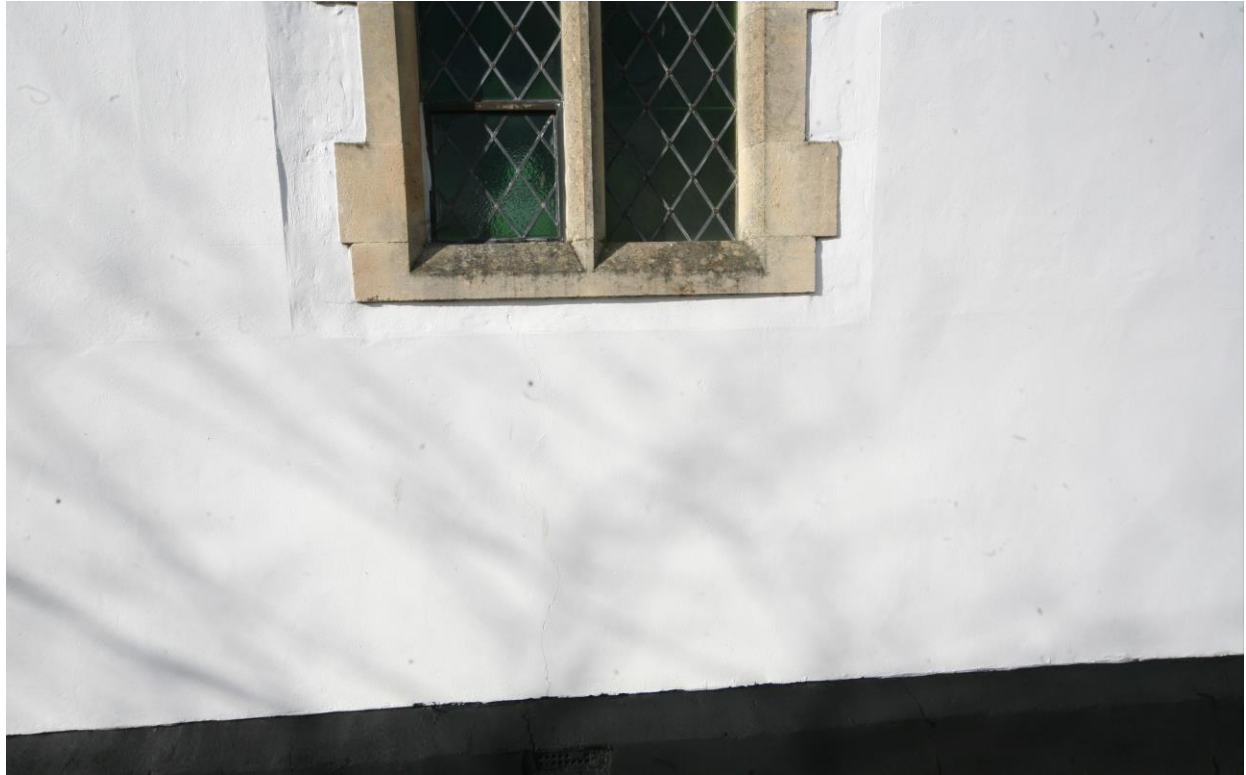
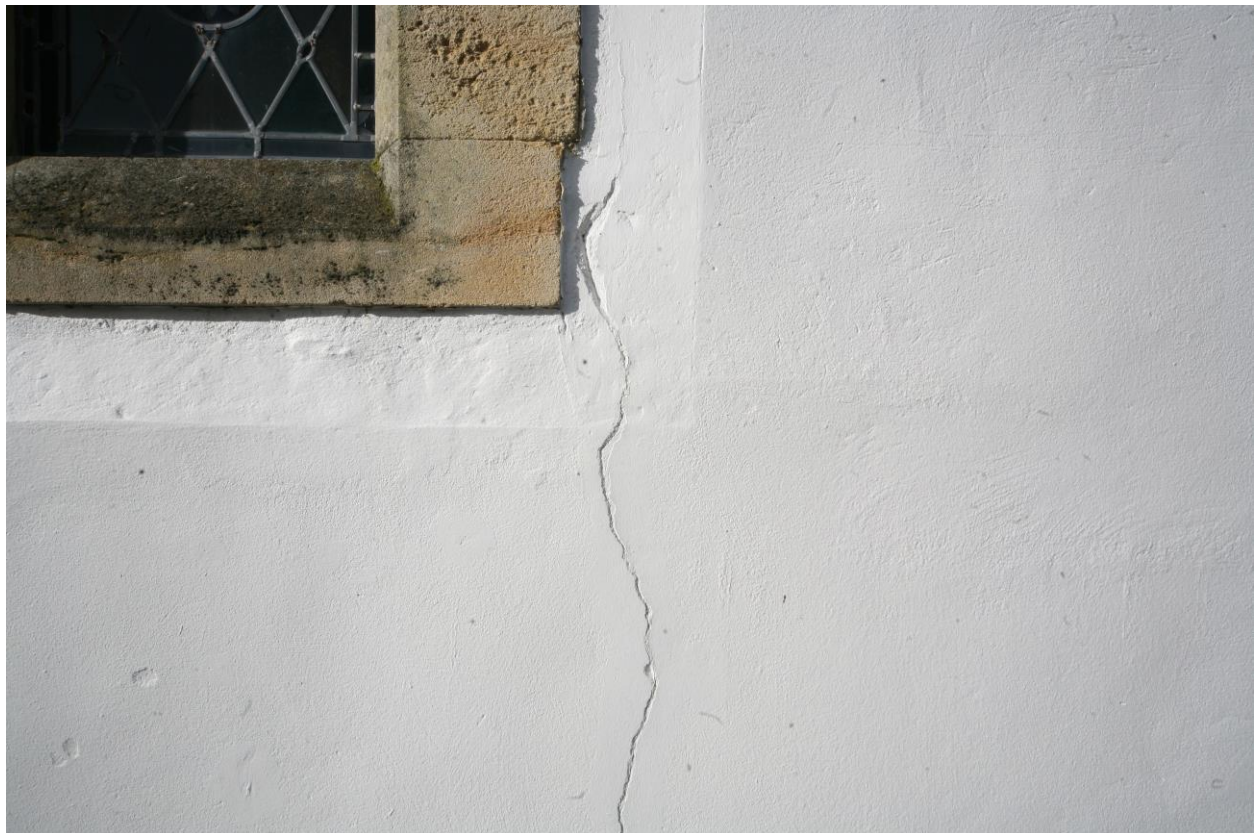
Typical examples of cracks in the cement render – these need filling with silicate filler before the wall is painted with the silicate paint system.

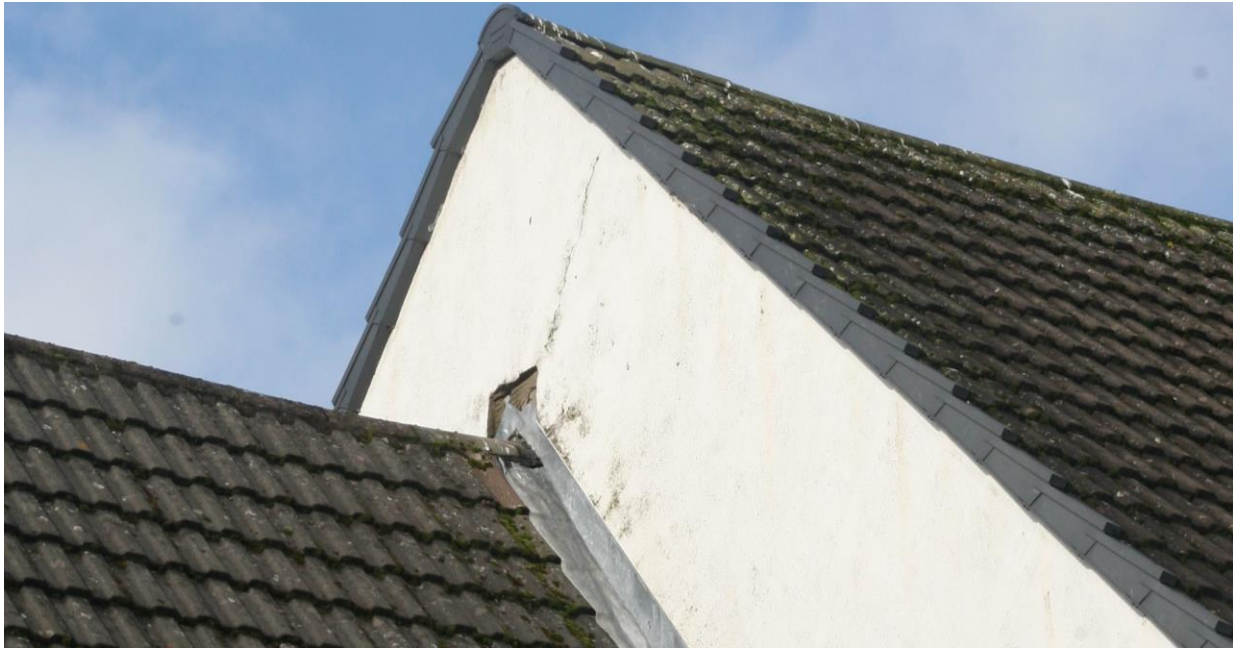
The render should be patch repaired with Ecomortar C and fibre – and the crack filled with silicate filler before applying the silicate paint system.

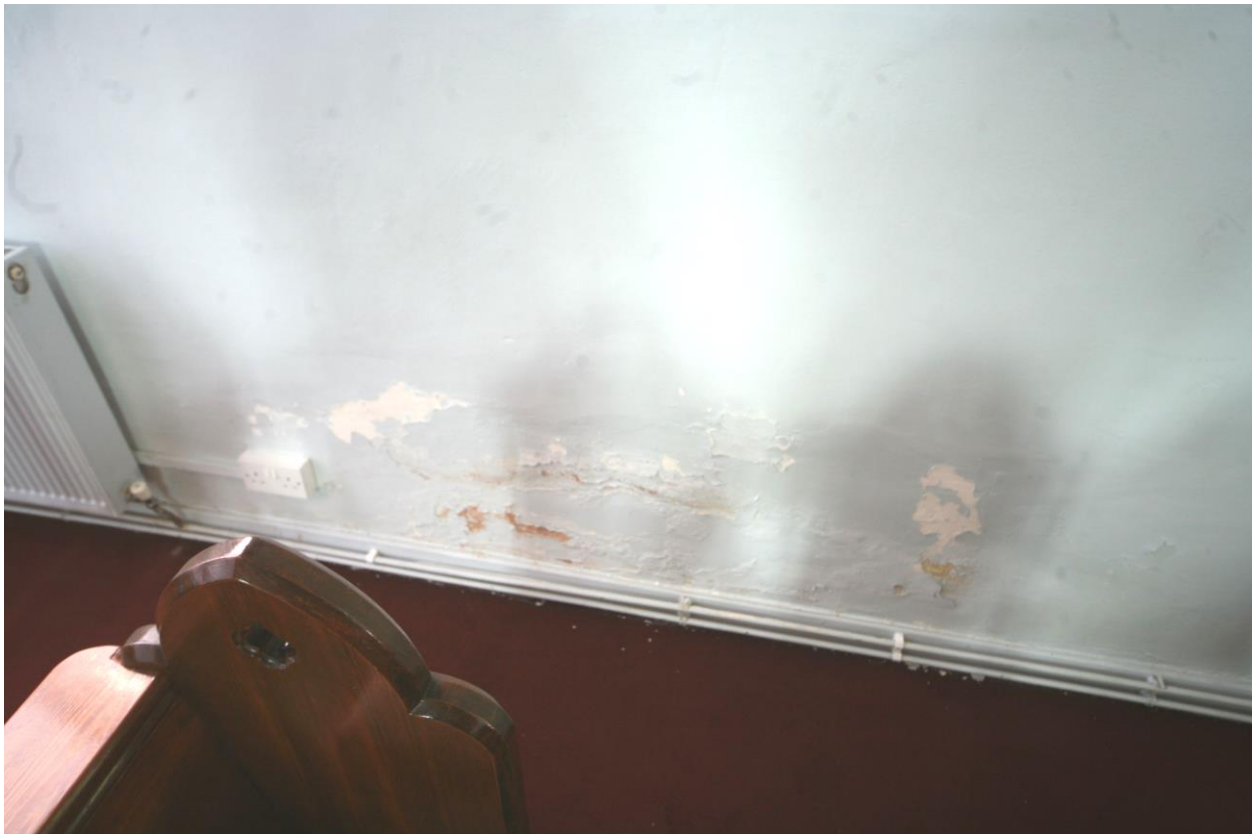
Walls should be allowed to dry before re-plastering. Care needs to be taken at the junction of new and old plaster

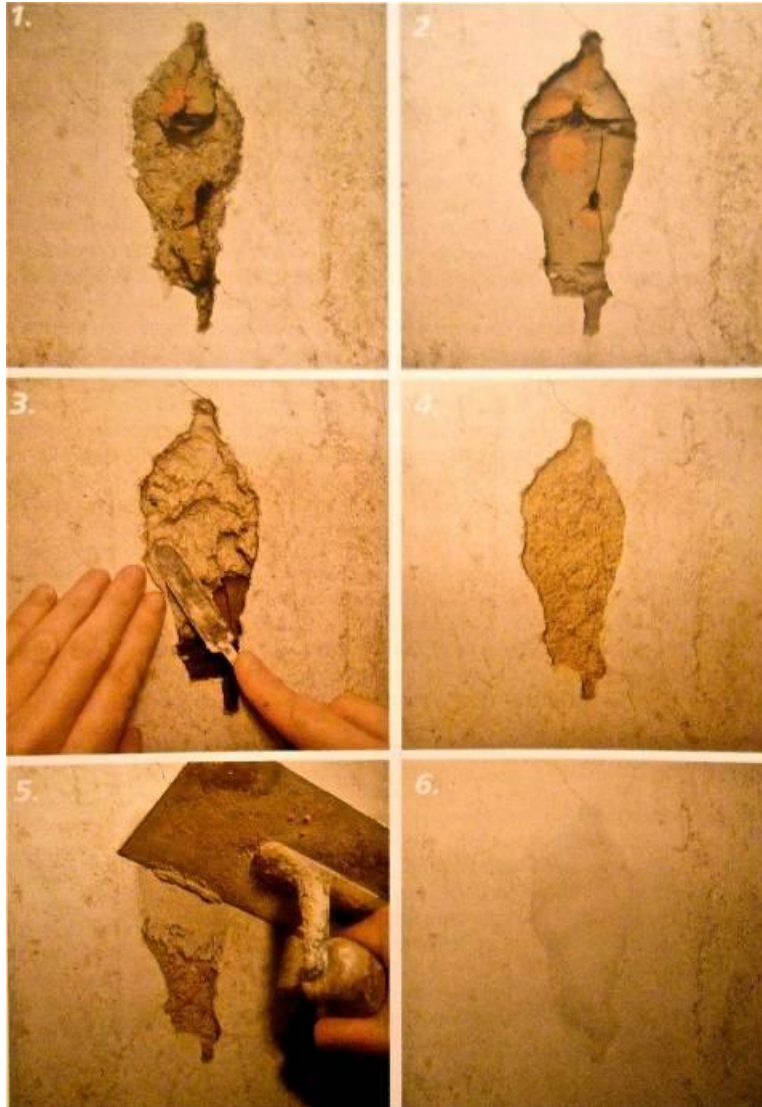
The sequence of a small patch repair.

1. The area to be patched, 2. The area is cleaned back to the substrate and the edges of the area to be repaired are slightly undercut using a sharp craft knife to help provide a key for the repair, 3. The area is thoroughly dampened and the lime plaster pressed onto the backing, the undercut edges are supported whilst plaster is pressed into the recess – if using a sand lime hair is necessary to reduce the risk of shrinkage, 4. The plaster is brought up to below the finished level, it is allowed to pick up, then keyed by scratching, 5. The base coat is dampened before a topcoat is applied flush to the surface and dampened to control drying, 6. The patched wall ready for painting

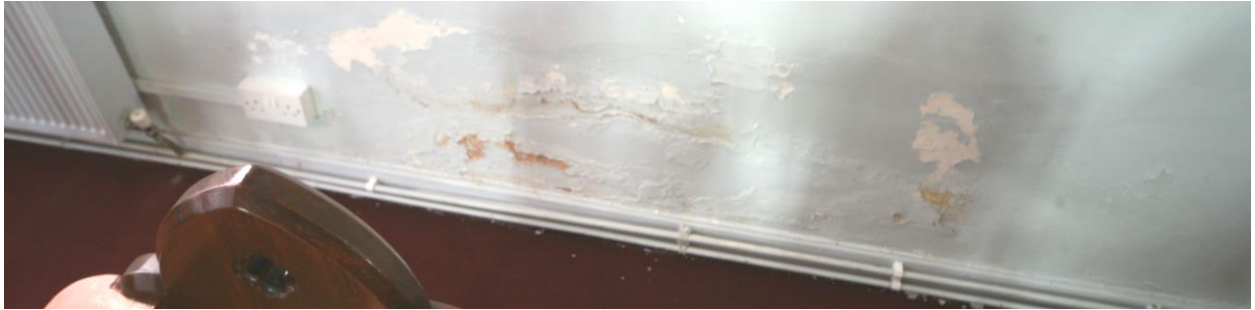
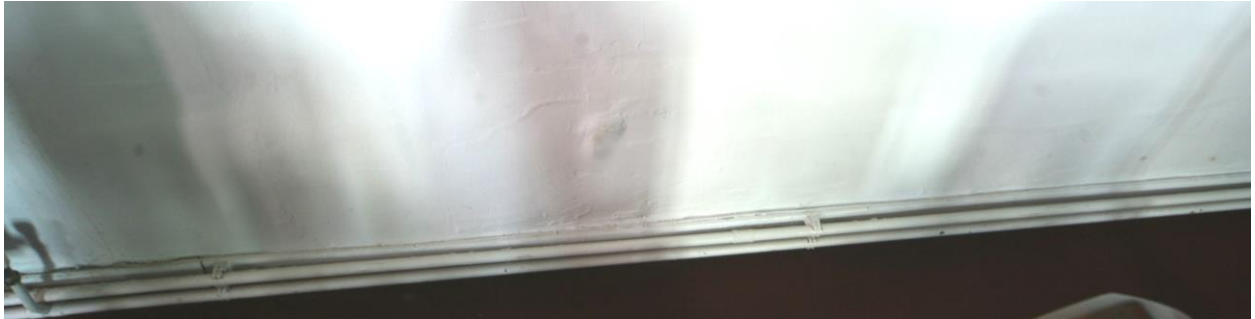
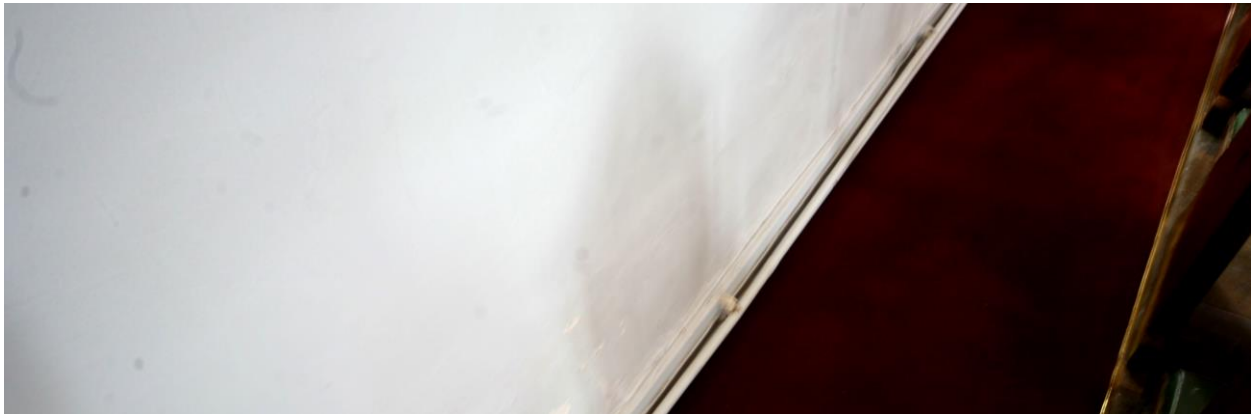
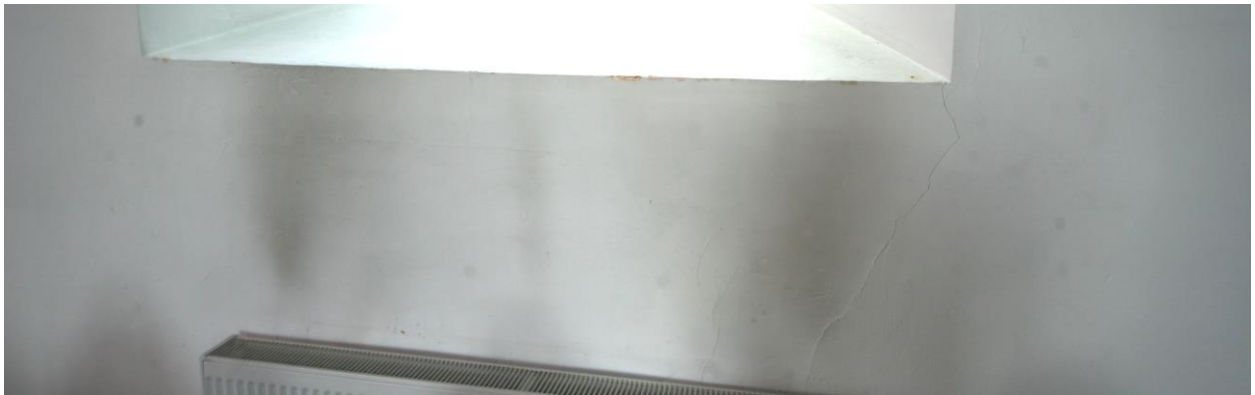
Typical areas of blowing paint and plaster due to a buildup of moisture and salt efflorescence due in most part to cracks in the external render. Heat within the church will draw moisture to the inside of the walls. Damaged areas should be removed back to sound dry plaster then allowed to dry before patch repairing. Volvox casein filler can be used for cracks before repainting is carried out.

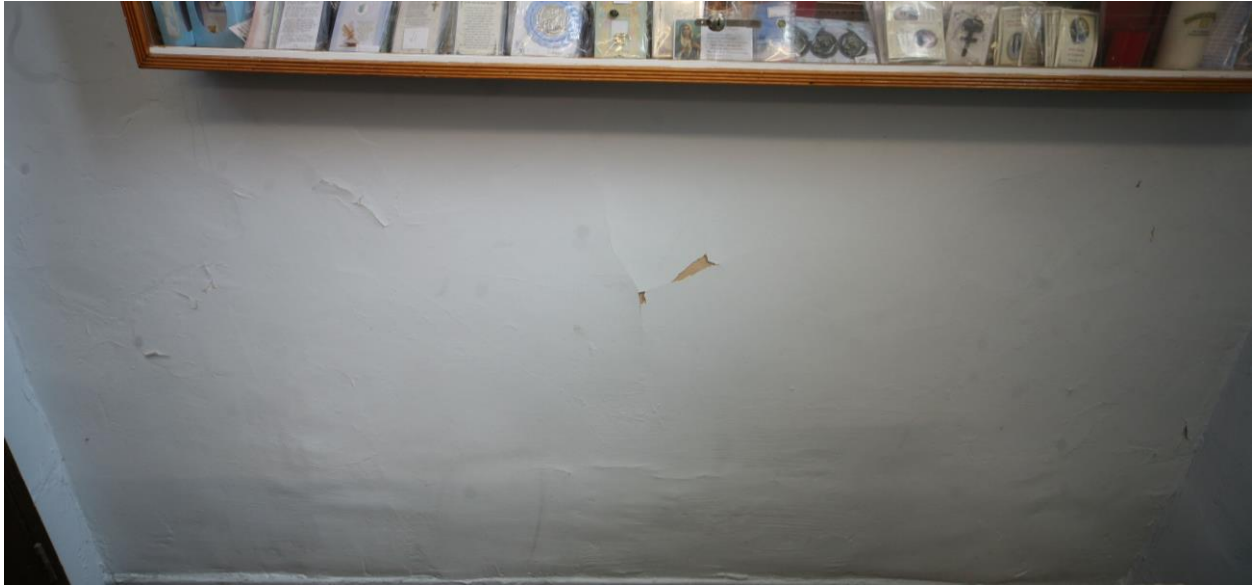
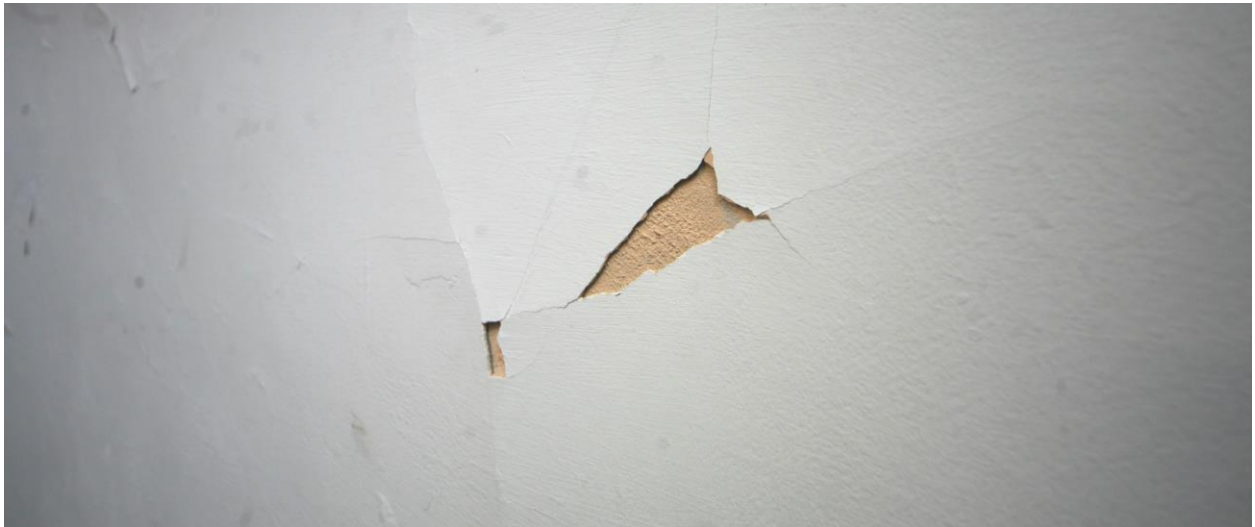
Cracking of a thick layer of emulsion paint – modern emulsion contains acrylic which means the paint forms a ‘skin’ over the surface which can crack due to moisture being trapped behind, surface tension or temperature variation. This area should be scraped back before being re-painted with Insil. If the top surface has come off with the paint then areas can be patch repaired with EcoMortar R50

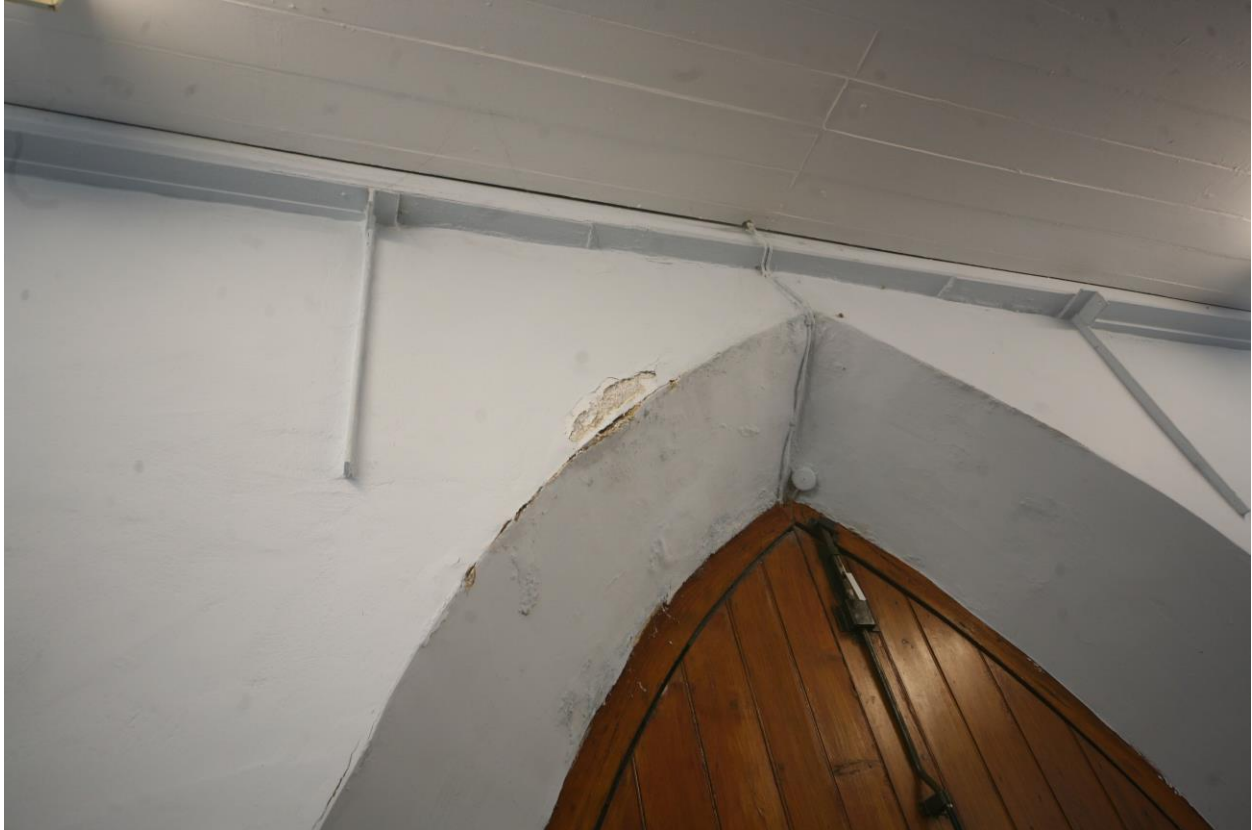
Water ingress on the west end, probably historic from the damaged coping stones (now covered with fibreglass) has built up under the plastic paint causing it to blow. Metal corner beads around the door have rusted and expanded causing further damage. It would be prudent to remove the rusty corner beads entirely if it is relatively straightforward or cut out rusted sections if not and patch repair and put back stainless steel or plastic beads.

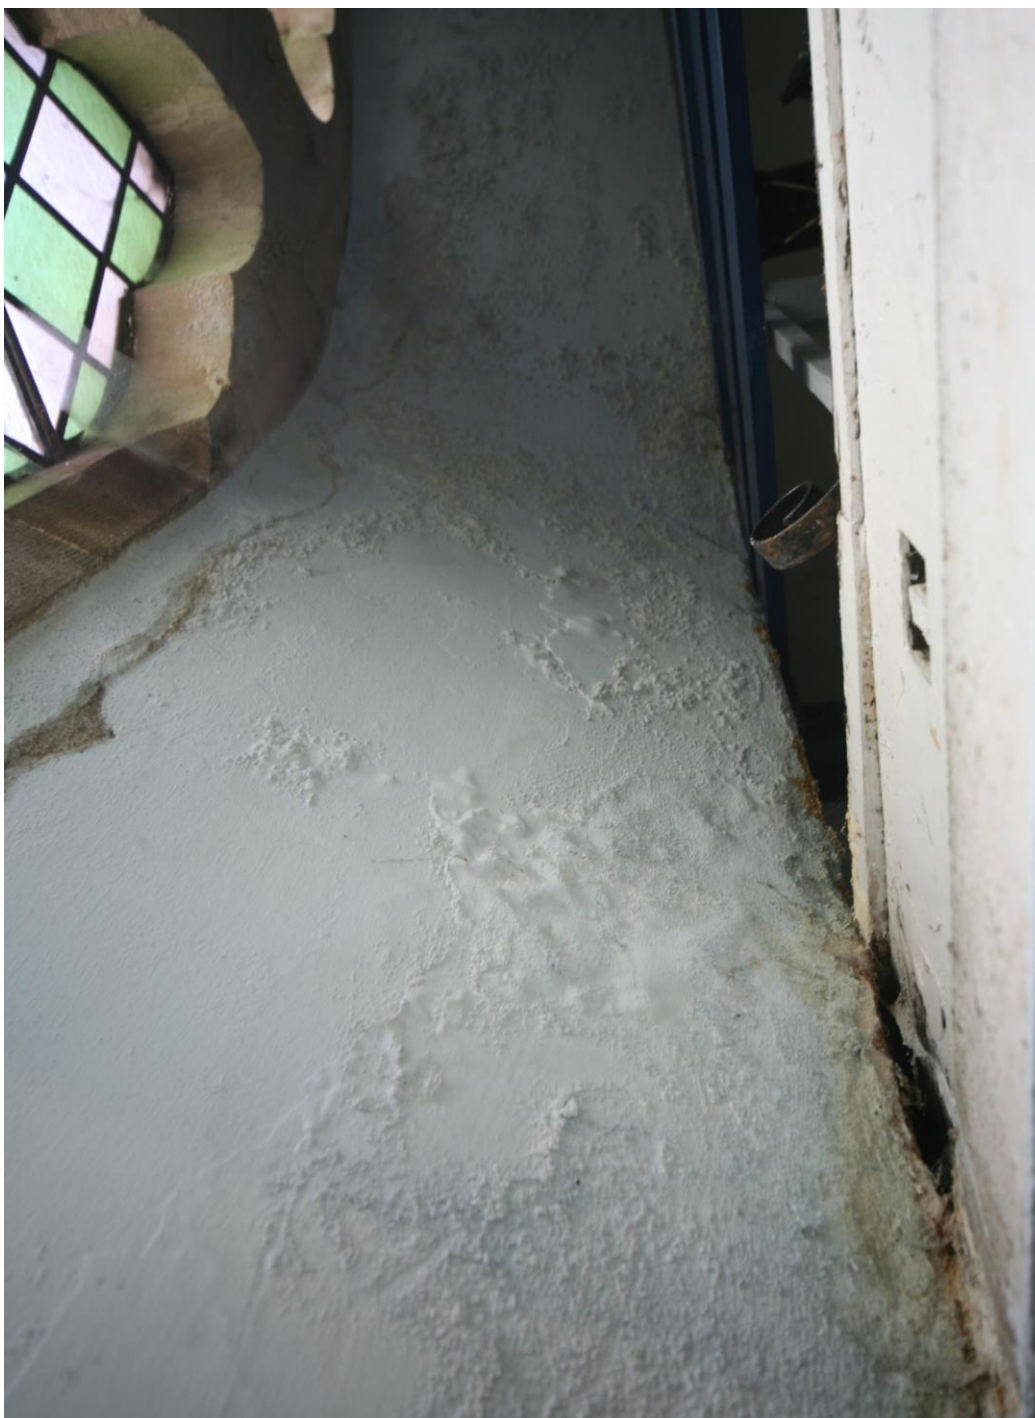
Areas of blown plaster and plaster with salts in (shown by the white salt efflorescence clearly visible) should be removed. The wall allowed to dry and patch repaired with R50. Ultimately when the wall dries the salts should stop moving through the wall however this can be a long slow process. A silane primer can be applied before painting in insil. If the wall remains getting wet then ultimately salts will come through a silane primer. Do not wash off salts as they will just get reabsorbed into the wall instead dry brush and vacuum.

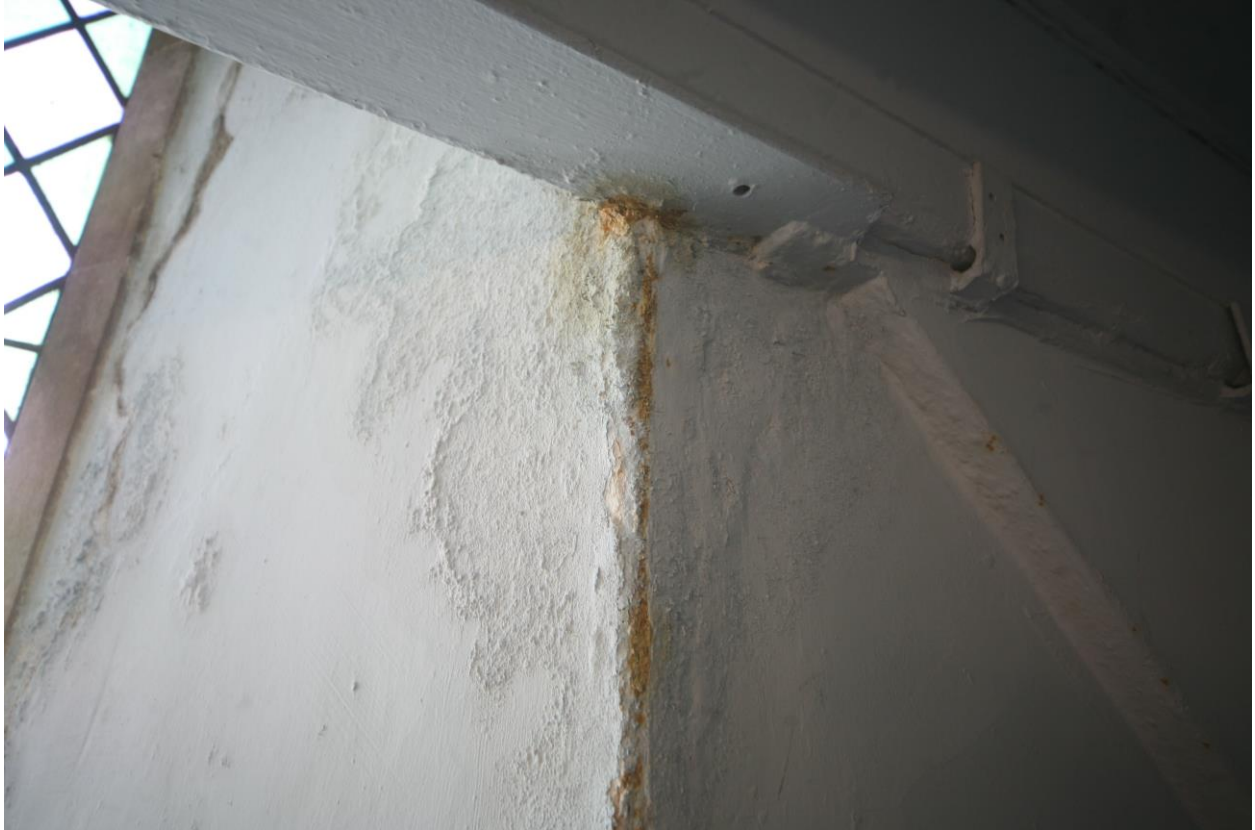
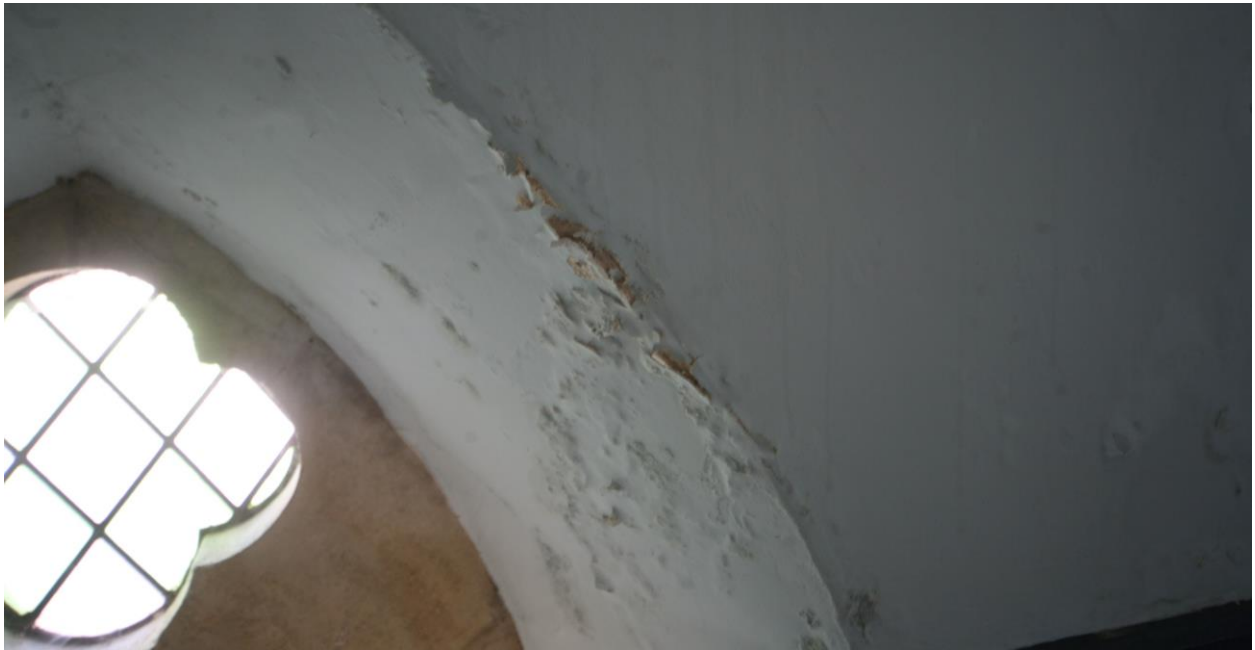
Salts clearly seen on this wall. Simply painting over in insil will not solve the problem and the insil will come off within a few months. Again here the rusting corner beads should be removed and replaced with stainless steel or plastic.

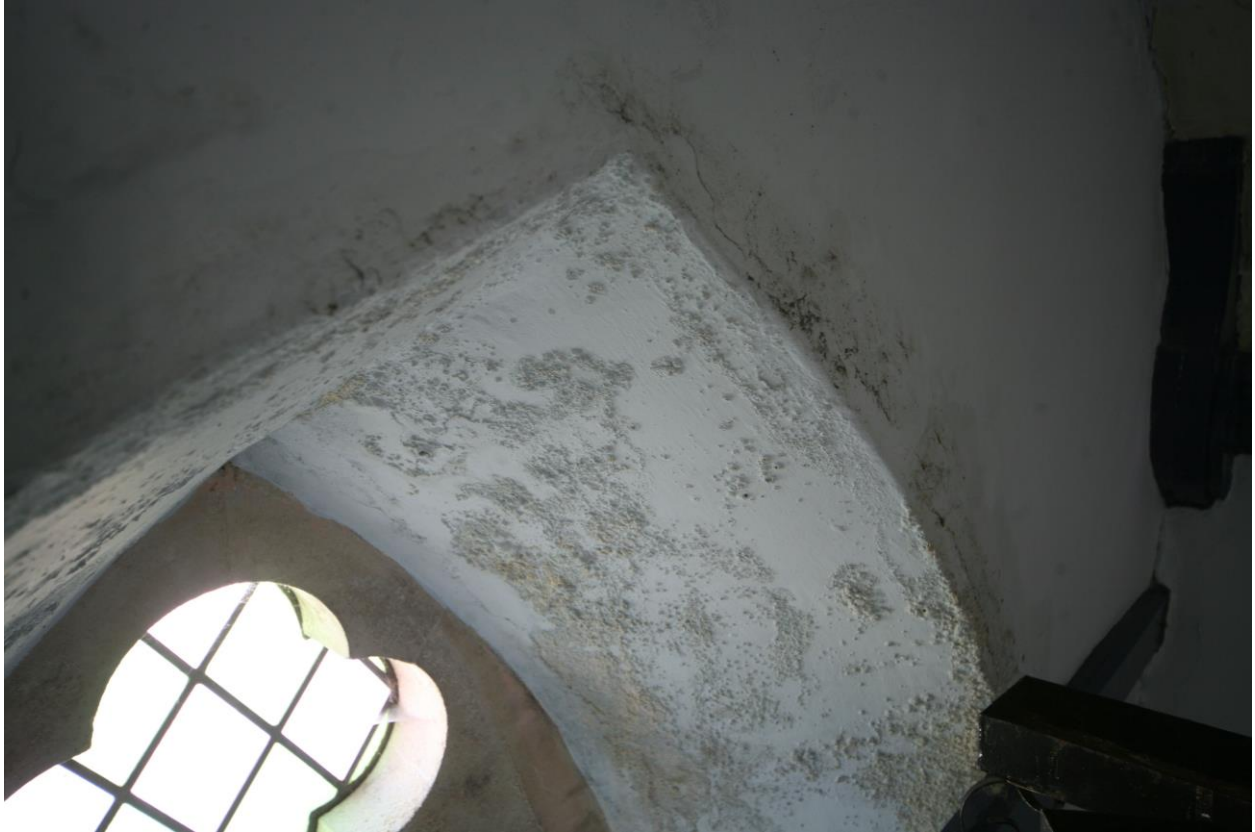
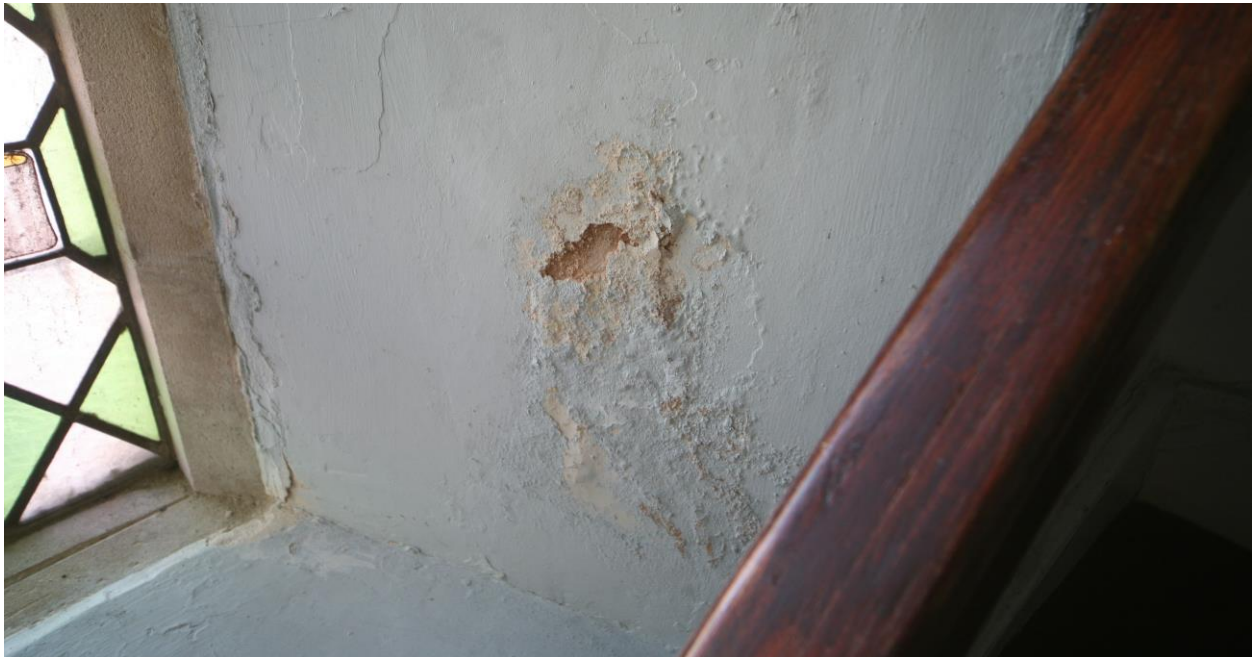
Salts coming through the wall and bubbling off the synthetic emulsion paint which is holding it back. This area should be removed and the wall allowed to dry before patch plastering.
