Site Visit Report

All Saints Church Ebbw Vale

February 2015

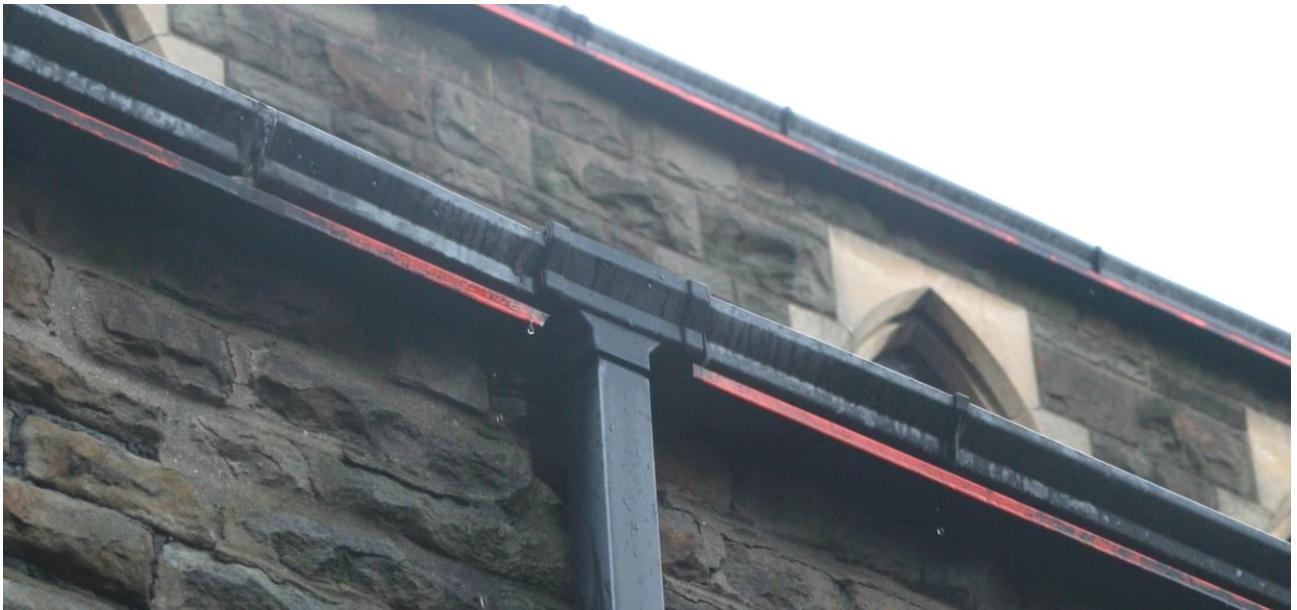
A dislodged gutter connection with the downpipe causing water to run down the face of the wall leading to saturation of the wall. The plastic guttering system is not ideal as it tends to move with changes in temperature and will require vigilance to ensure there are no loose connections.

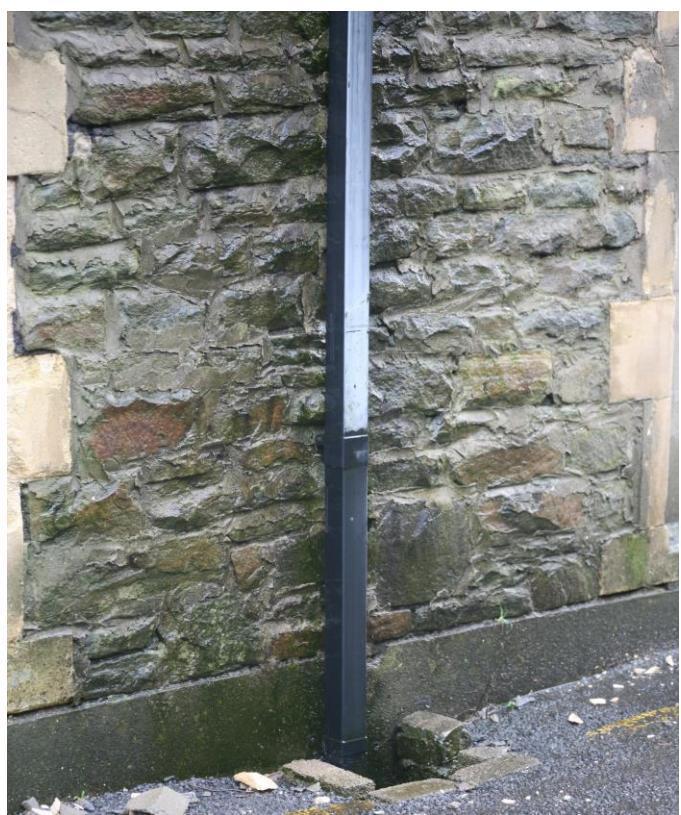
Wall saturated from the leaking gutter connection

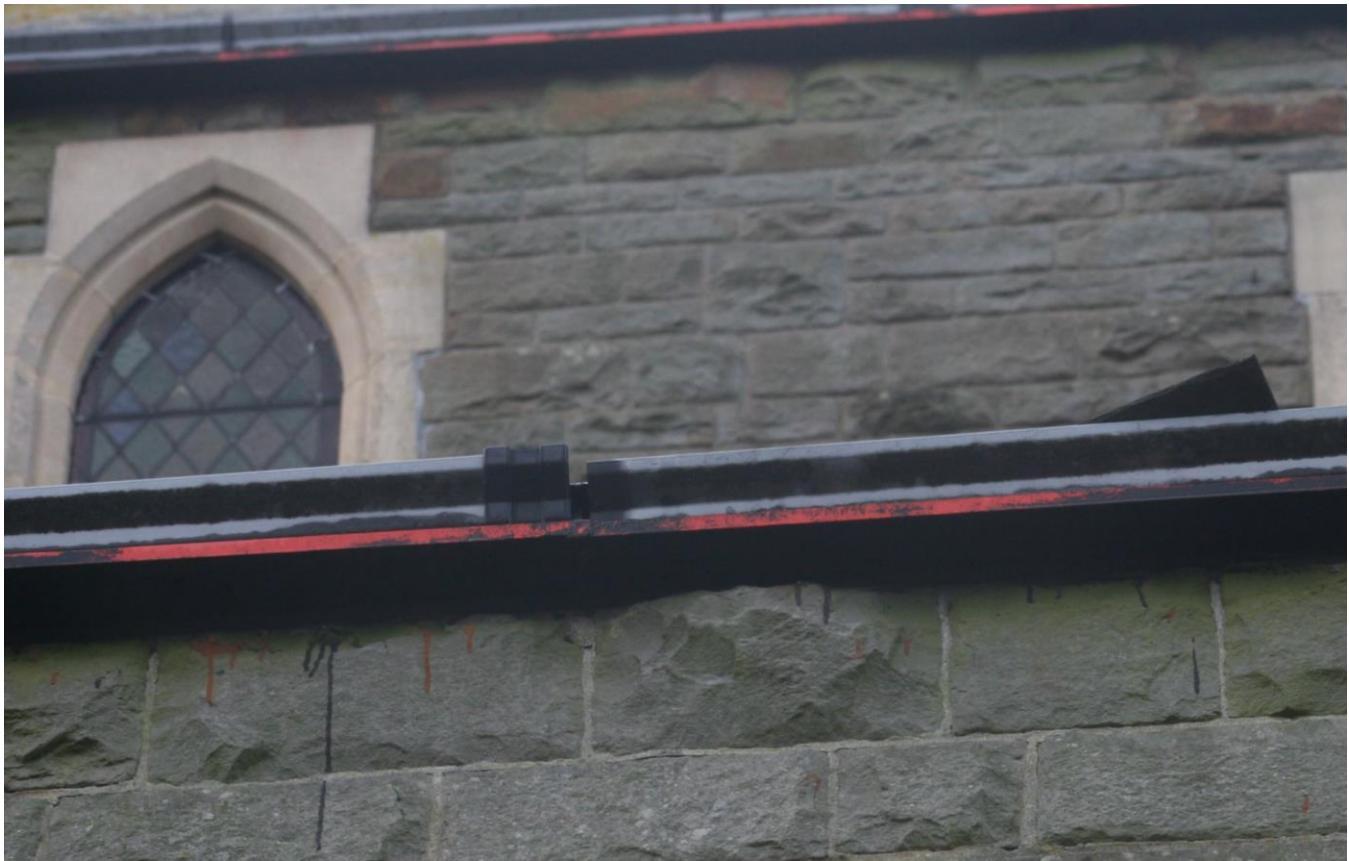
On the east facing elevation another gutter has detached from its connector allowing water flow down the wall. There appears to be a slipped slate next to it in the gutter.

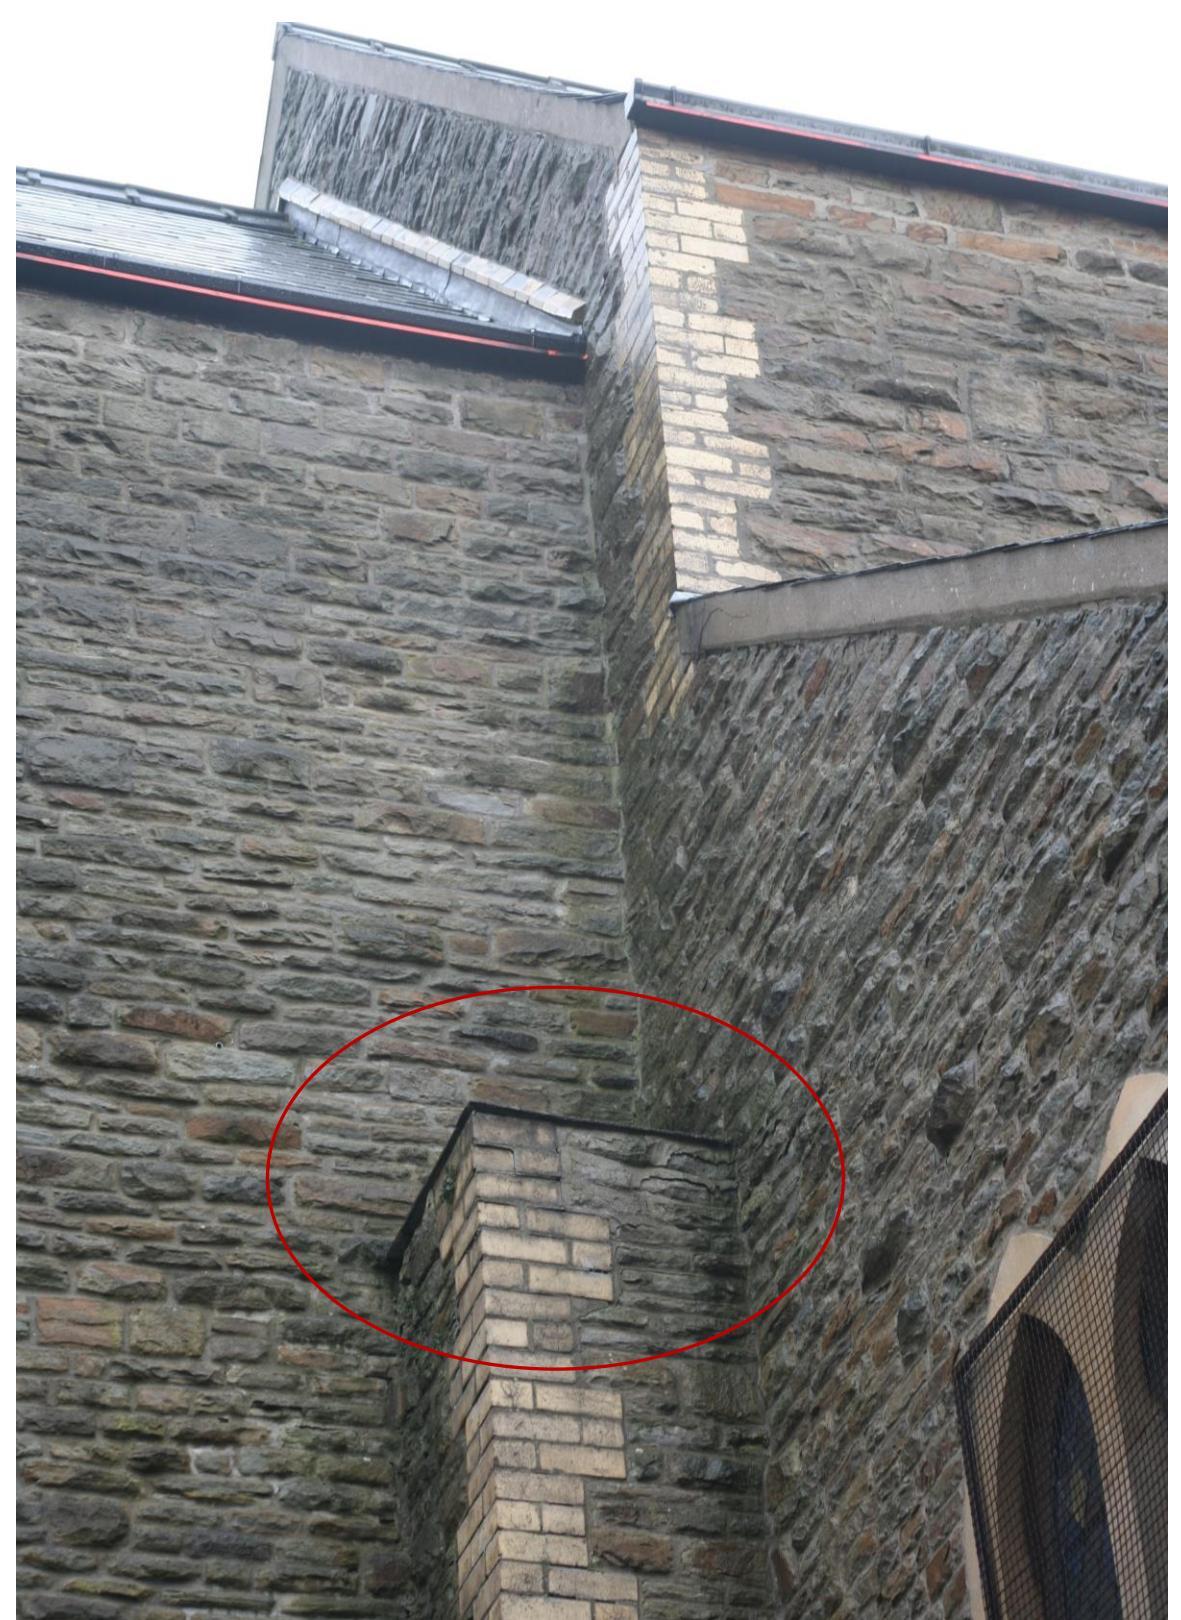
...An area for water to sit and flow back against the wall – the installation of a sloped flaunching or lead or tile run off would be a good idea.

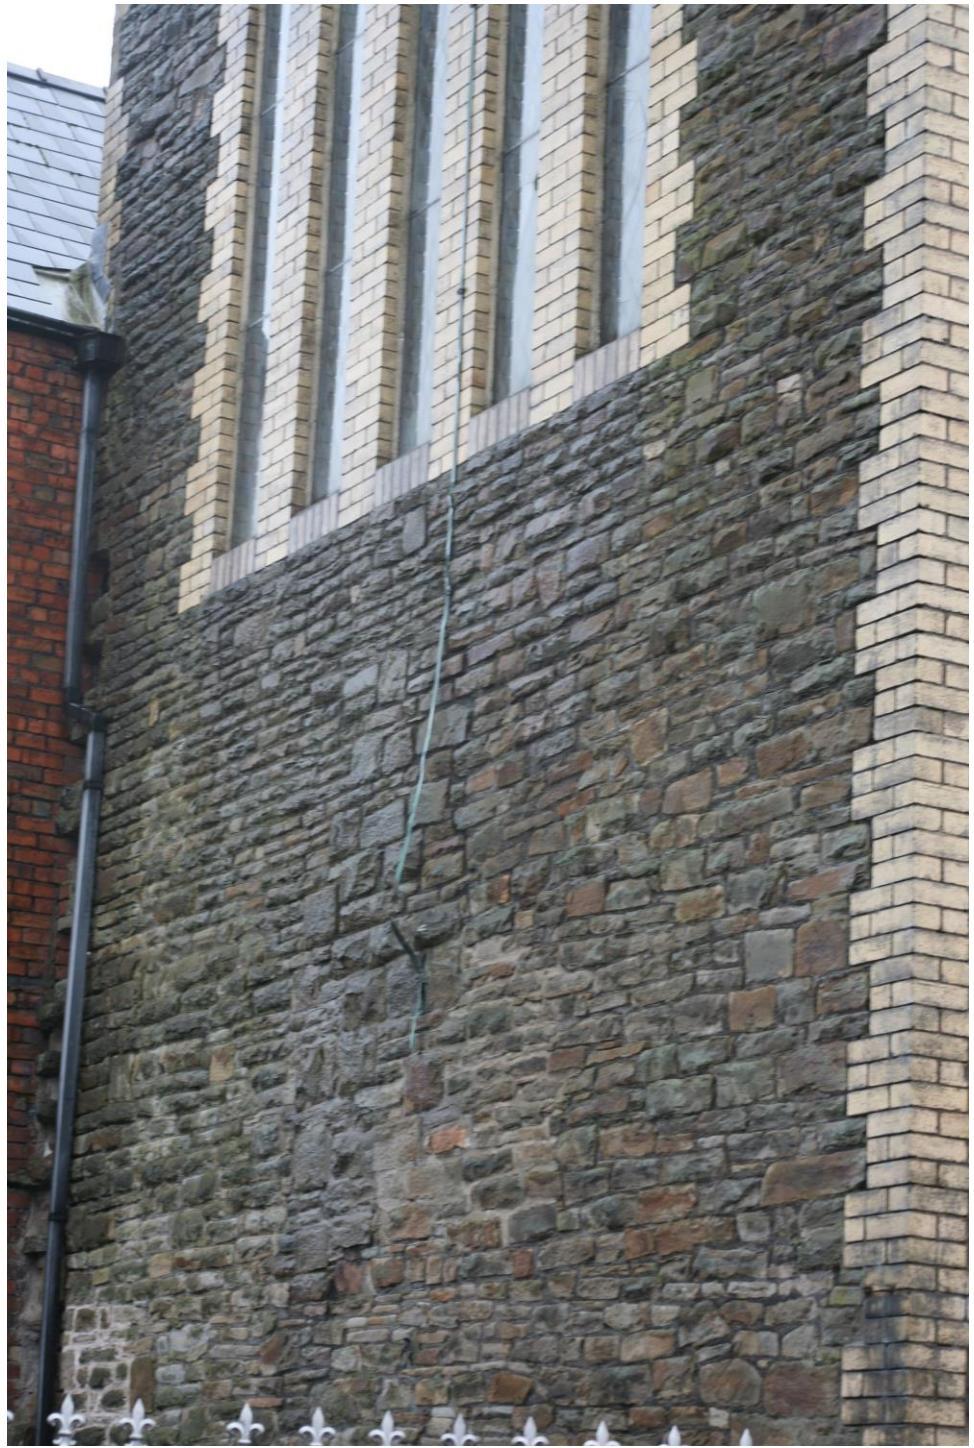
Water running down the end gable. Some of this will simply be from rain hitting the gable but some may be water runoff down the coping stones. Where pointing has failed this will be taking water in.

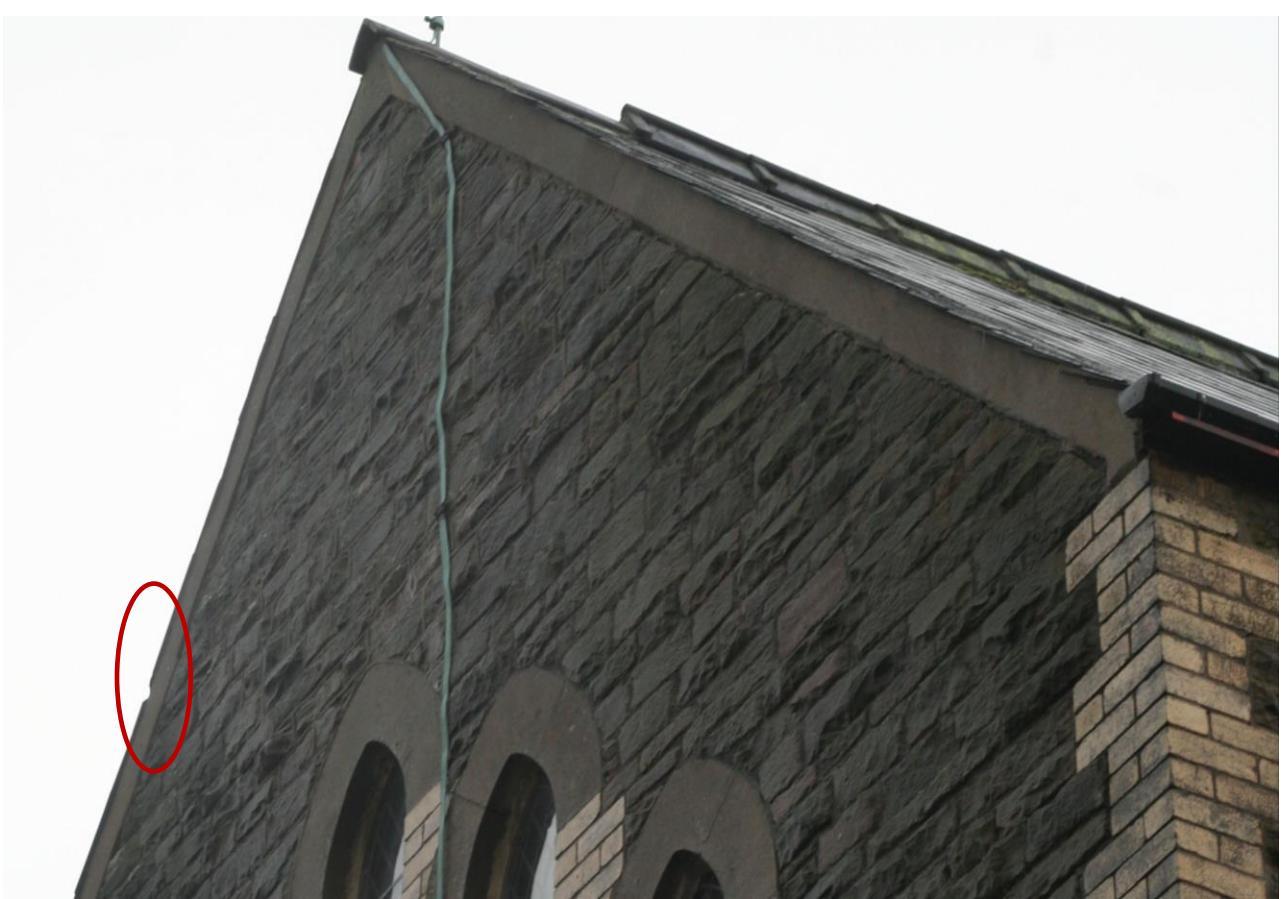
The gable end which appears extremely wet - breaks in slates should be addressed

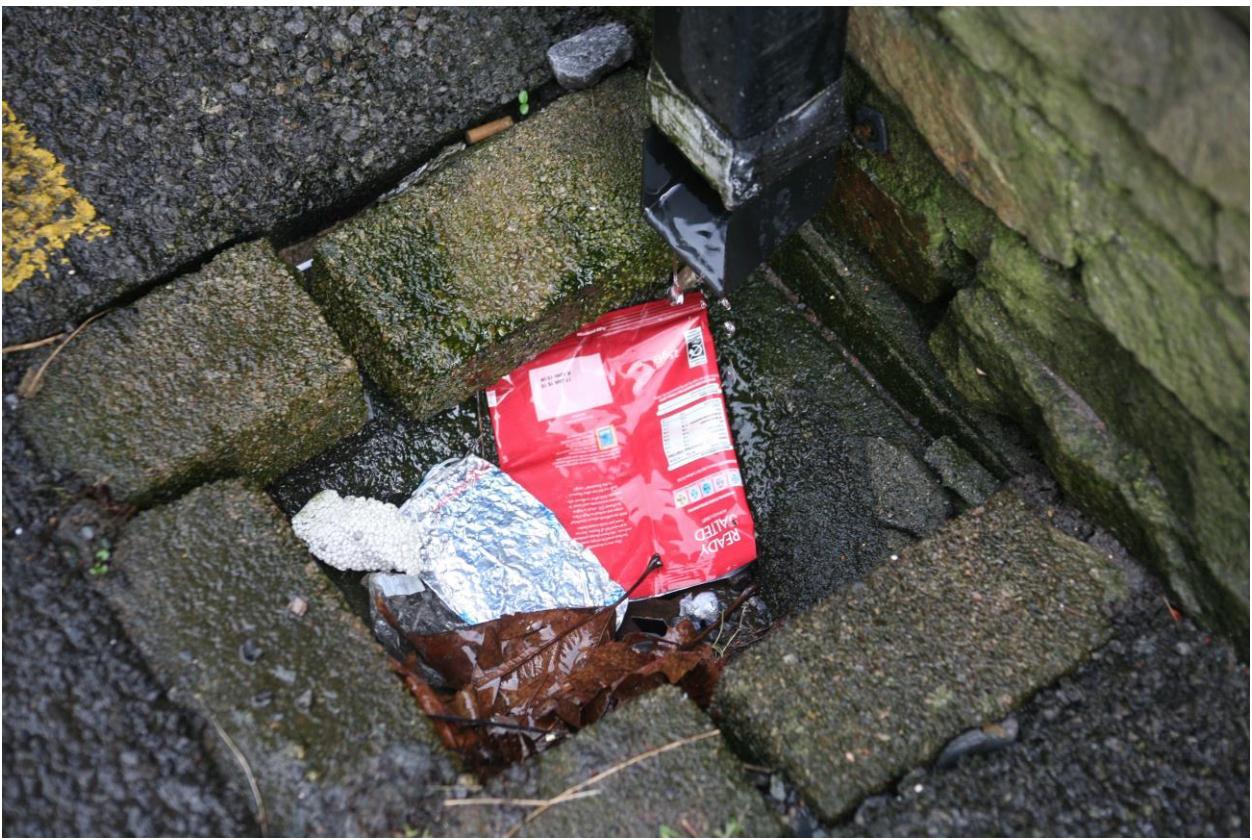
An example of an ineffective drain – this should be dug up and a new drain surround installed to ensure there is no water back flowing into the base of the walls.

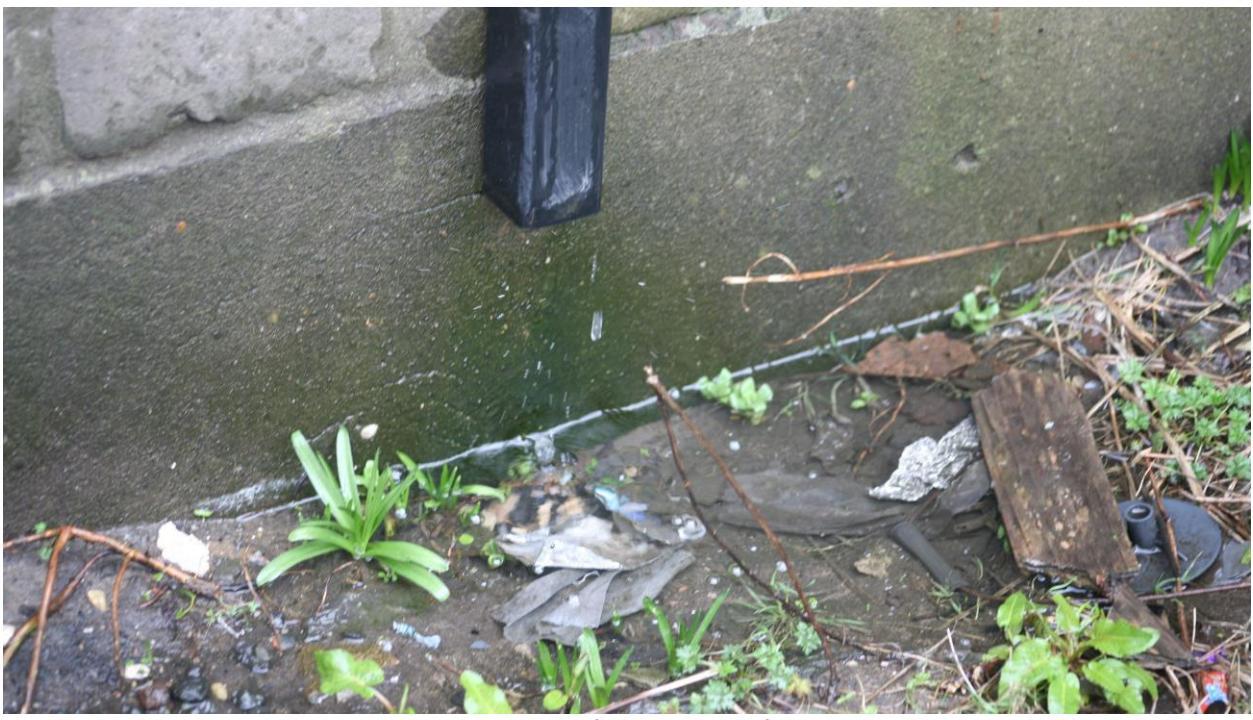
Without a drain water pools at the base of the wall before soaking in below resulting in a wet rubble wall – drains should be installed at <u>all</u> downpipes.

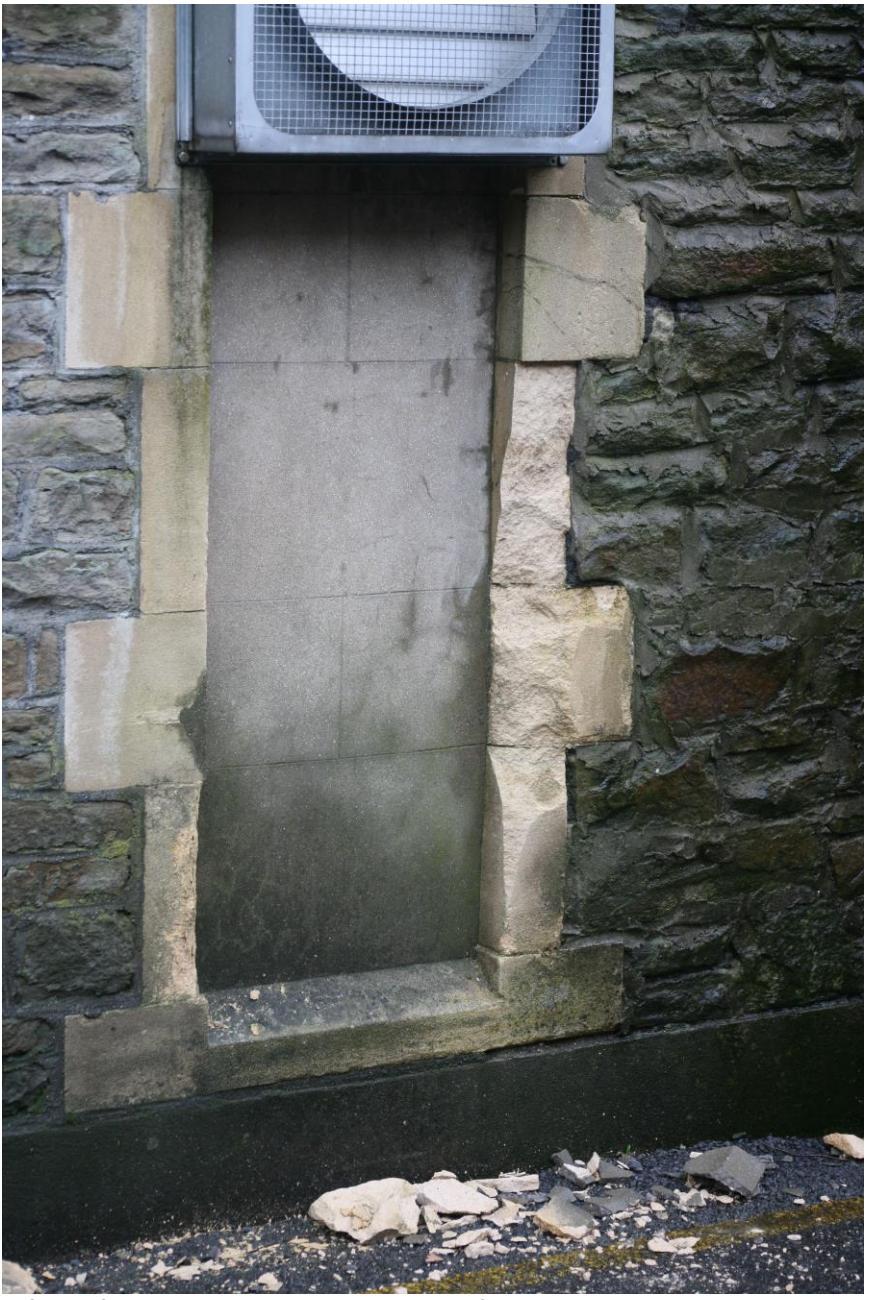
An example of the failed Bath stone – some of this is due to physical damage but also freeze-thaw weathering from saturated stonework and freezing temperatures causing the beds to fracture. These areas could be considered for lithomex stone repairs in many cases and actual stone replacement in others.

Where stone decay has taken place a stone mason should be employed for stone repairs and isolated stone replacement. In areas such as the door and window surrounds loose stone should be removed and it may be appropriate to carry out hydraulic lime plaster repairs with lithomex stone repair mortar.

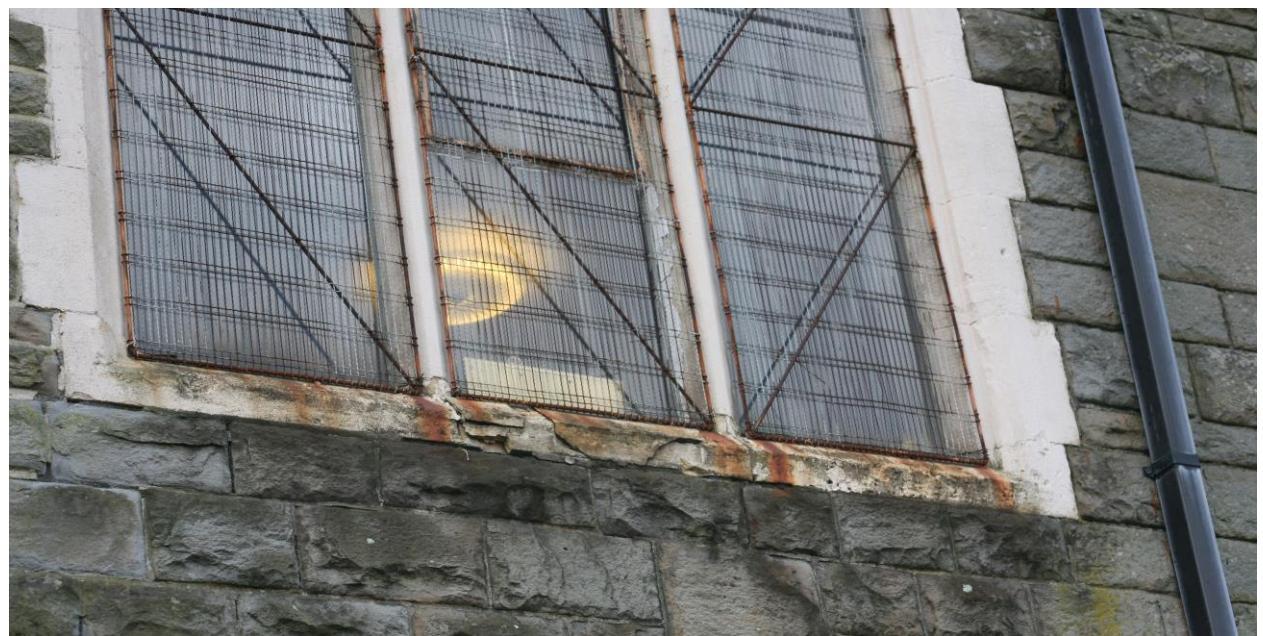
An example where stone repairs are necessary not just aesthetic considerations – all damaged window sills should be repaired to allow the effective run-off of water. Lithomex stone repair mortar can be used unless the stone has completely disintegrated.

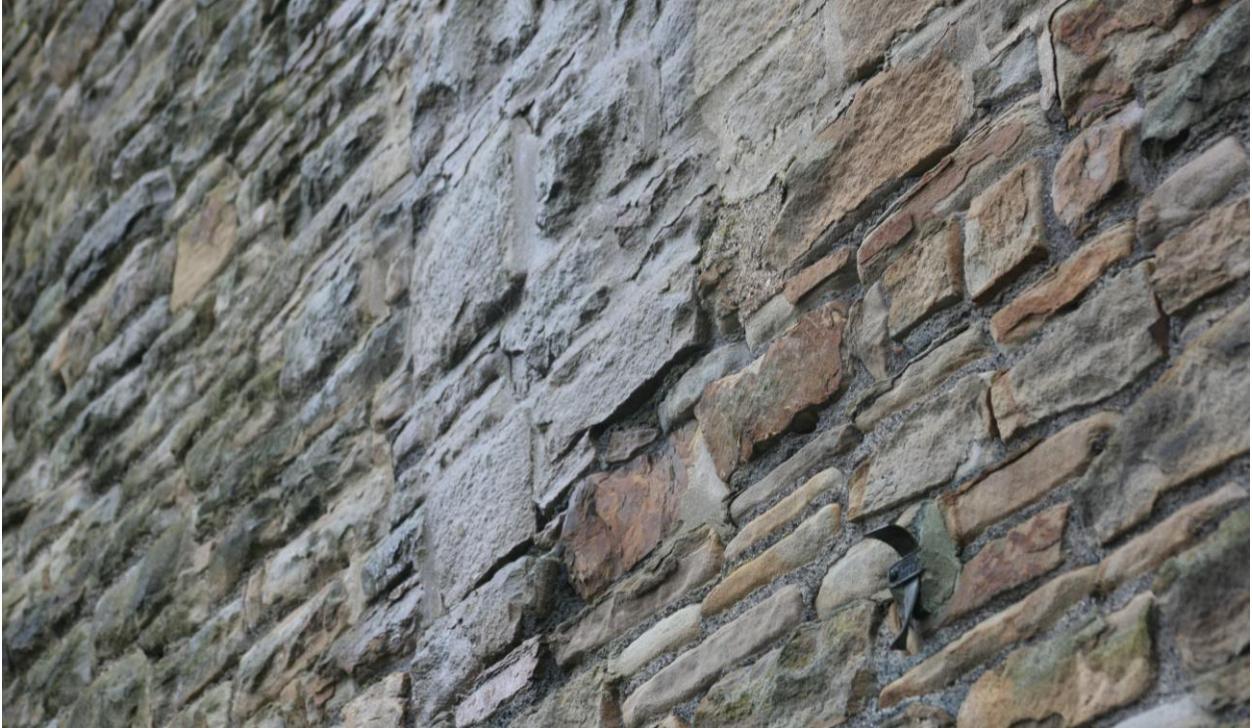
An example where isolated repointing would be sensible. The cement should be raked out, the wall allowed to dry, then be repointed with Blaenavon aggregate and NHL3.5 lime at 3:1 aggregate to lime.

Where re-pointing is required extreme care should be taken not to damage the stonework and plugging chisels or more effectively quirks should be used by hand – angle grinders and electric hammer chisels should **not** be used. If in doubt the pointing should be left in places where more damage would result from its removal. A minimal intervention approach is best with isolated pointing repair where needed.

The most appropriate material to use would be a 'blaenavon' NHL3.5 lime mortar to offer a similar colour match and some flexibility. The mortar should always be softer than the surrounding stone making it sacrificial to the stone. If undertaking work at this time of year a NHL3.5 hydraulic lime with 'blaenavon' aggregate should be used. Joints should be kept tight and the mortar sponged back to achieve a finish to blend in with the walls.

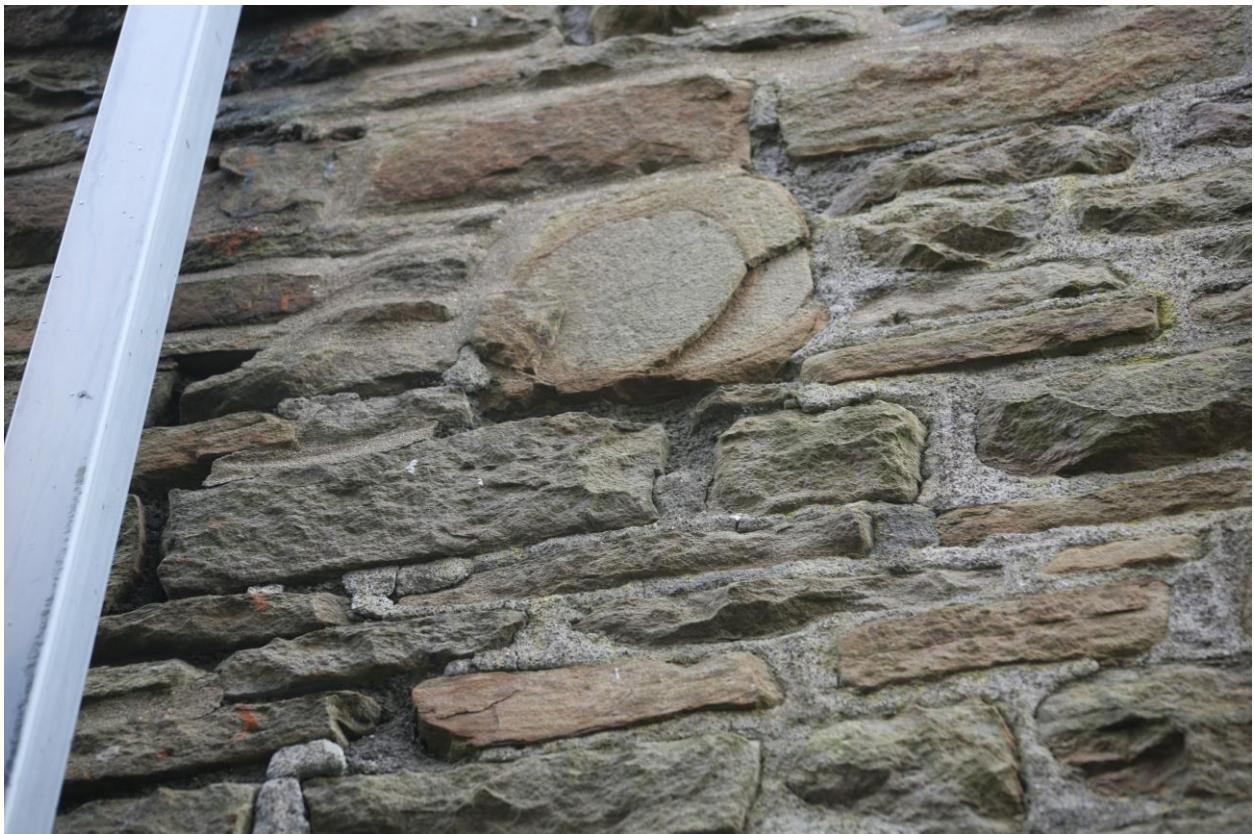
An example where re-pointing is needed in hollows or where the mortar has washed out entirely such as behind the downpipe.

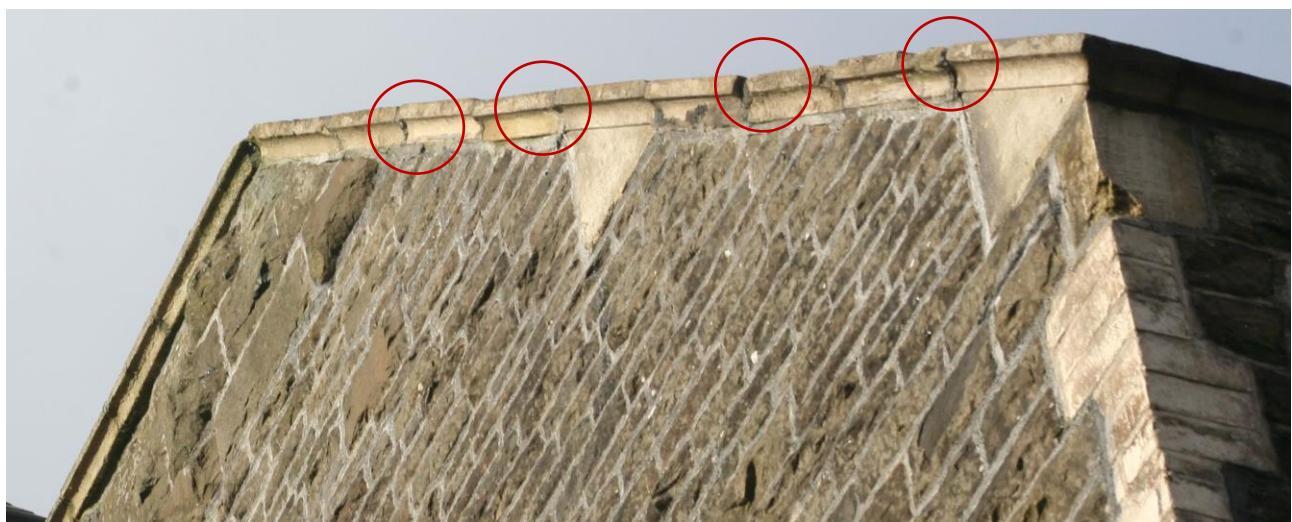
Uneven coping stones can lead to open joints where moisture can ingress

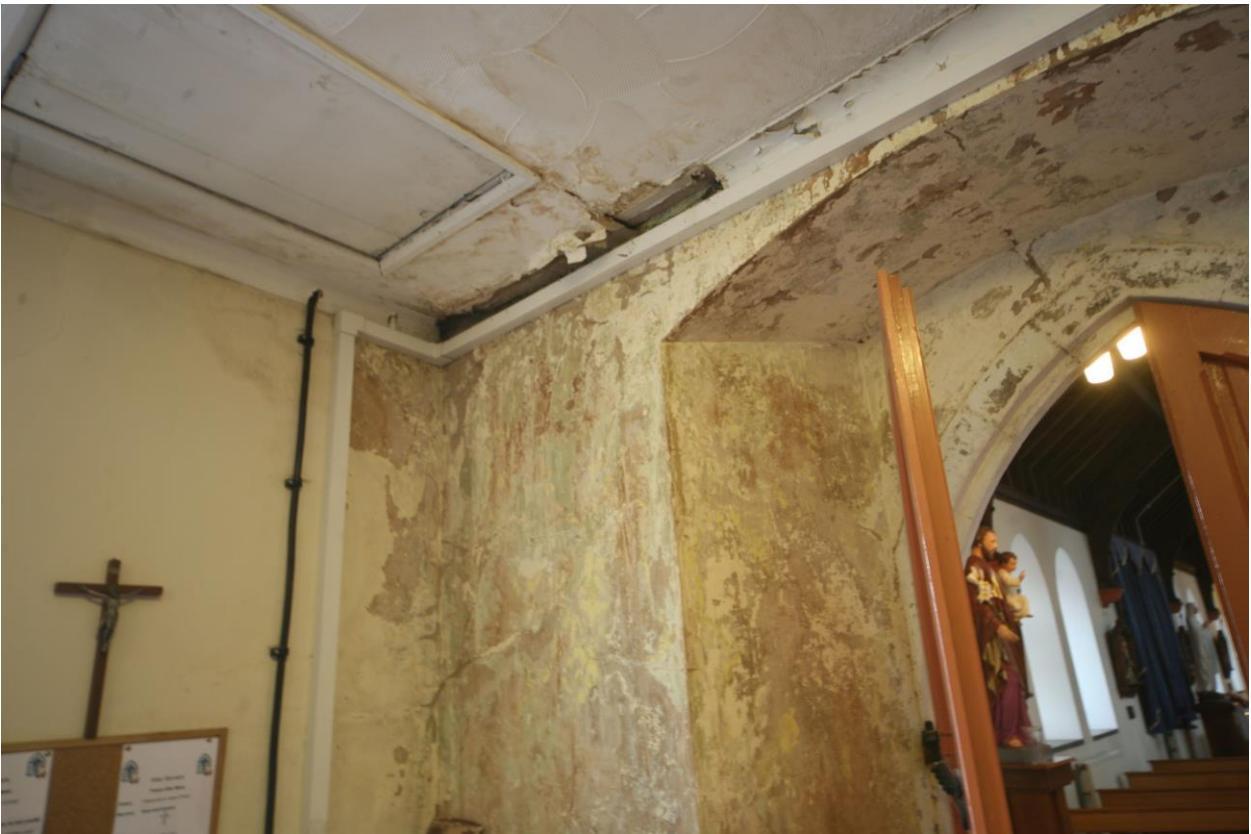
The interior of the building shows the effects of water ingress, especially at gable ends. The lime plaster has failed in numerous places. Large areas have blown and salts are coming through. A vinyl emulsion has been painted on the walls and after trapping moisture within the walls it is now blistering and peeling. This will also allow lots of condensation to form on its surface during services.

Walls should be allowed to dry before re-plastering. Care needs to be taken at the junction of new and old plaster

After the water ingress problem has been fixed, drainage installed and the walls allowed to dry the walls can be re-plastered.

If retaining areas of original plaster care must be taken with new plaster at the joints where the old plaster has been cut away. We recommend that at edges the old plaster should be slightly undercut to allow a good joint for the new plaster. There will be high levels of suction at the joints and they should be carefully wetted to minimize shrinkage and well finished working up to the cut edge. It is likely that the joint between the old and new plaster may show through. This can be disguised to an extent in the finish.

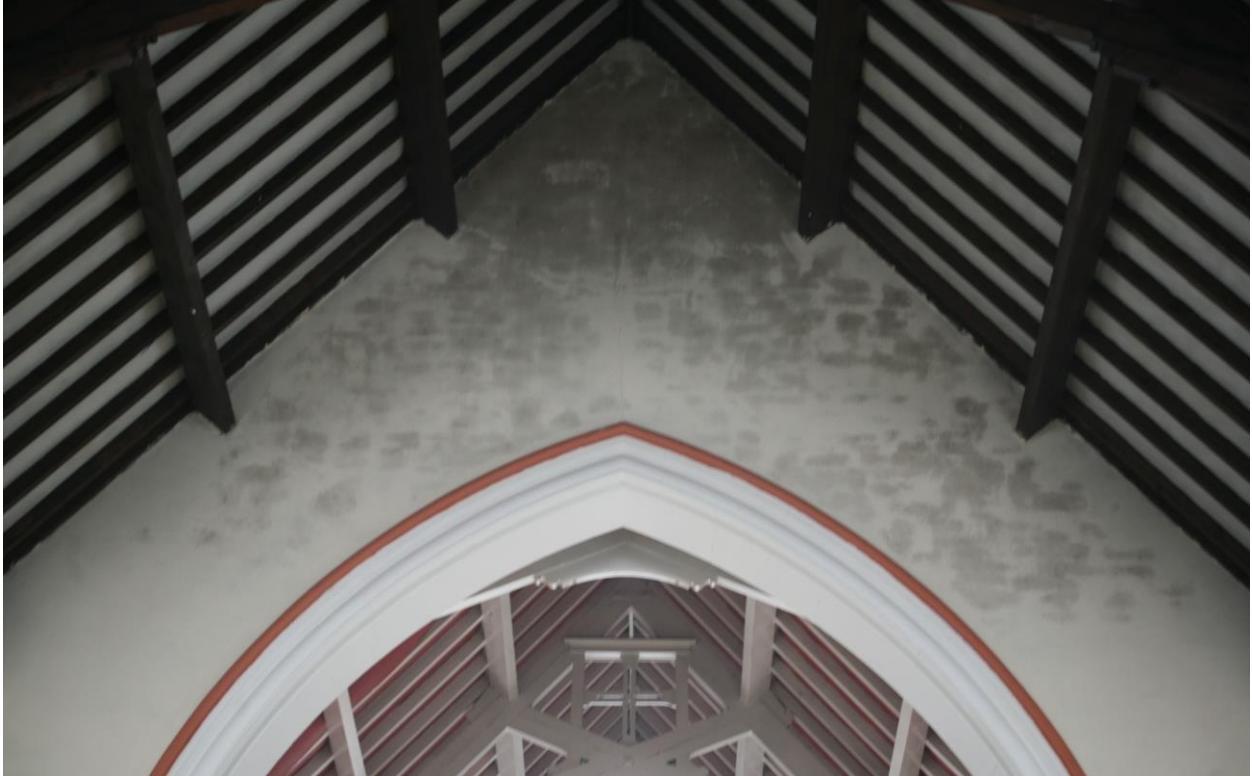
Signs of past water ingress on the chancel arch. If this is now dry and no longer getting wet the area should be painted with volvox isolating primer before being painted with Insil silicate mineral paint.

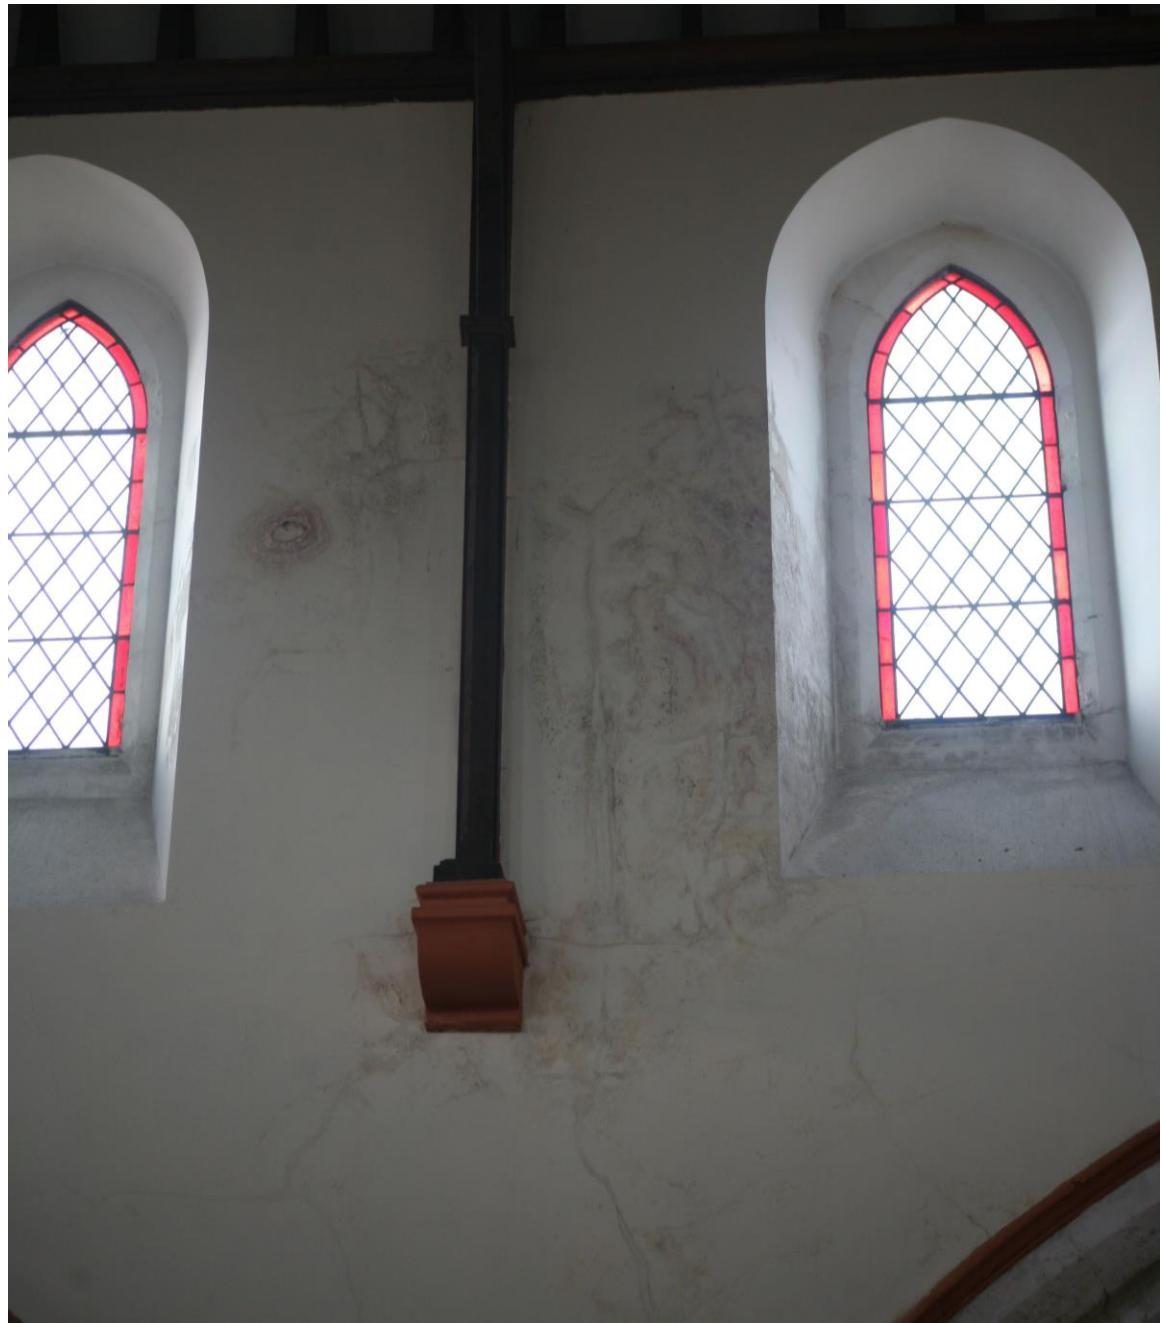
Water ingress high up in the nave corresponding with the leaking gutter outside. All loose and flaking paint and plaster should be removed then the wall allowed to dry out. Only after the wall has dried it can be patch repaired with Ecomortar R50. Small cracks can be filled with volvox casein filler.

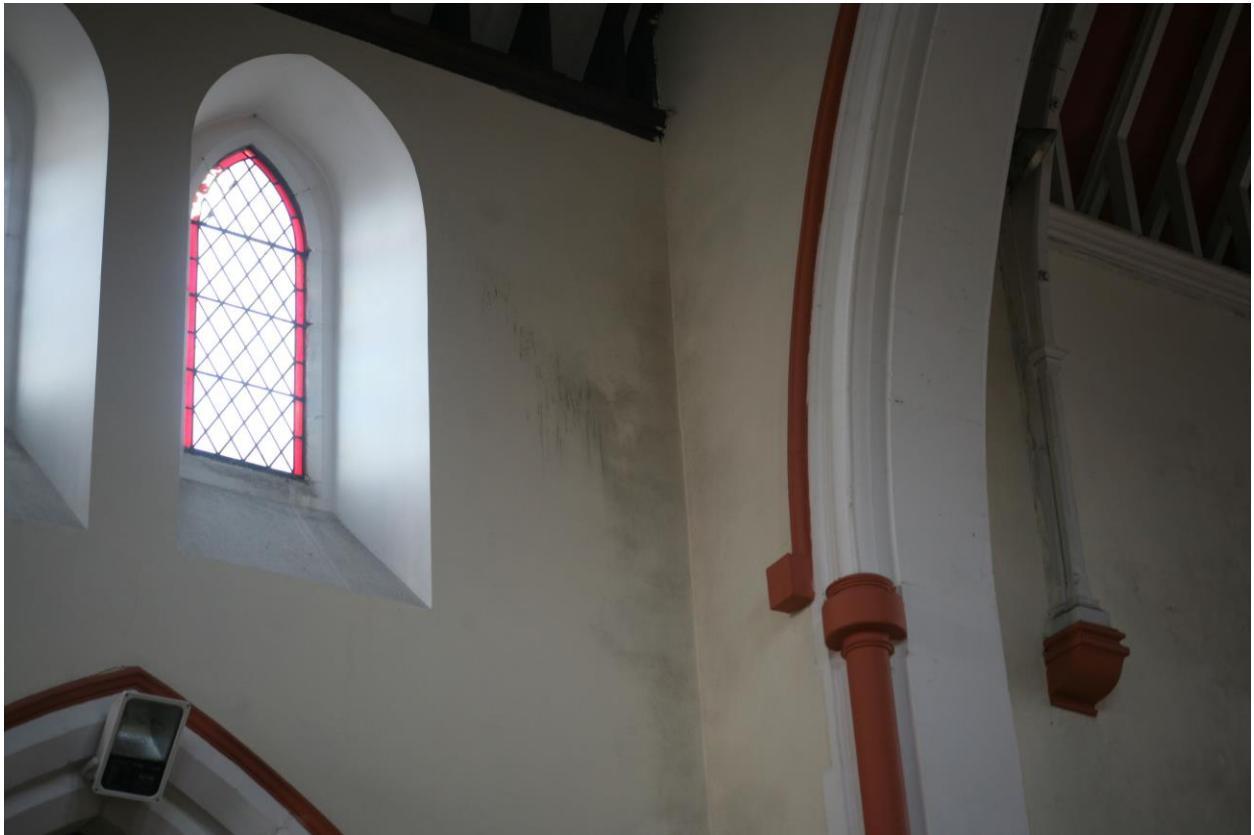
Staining from moisture and condensation this should be cleaned back with sugar soap and if stains remain painted with volvox isolating primer before being repainted in insil.

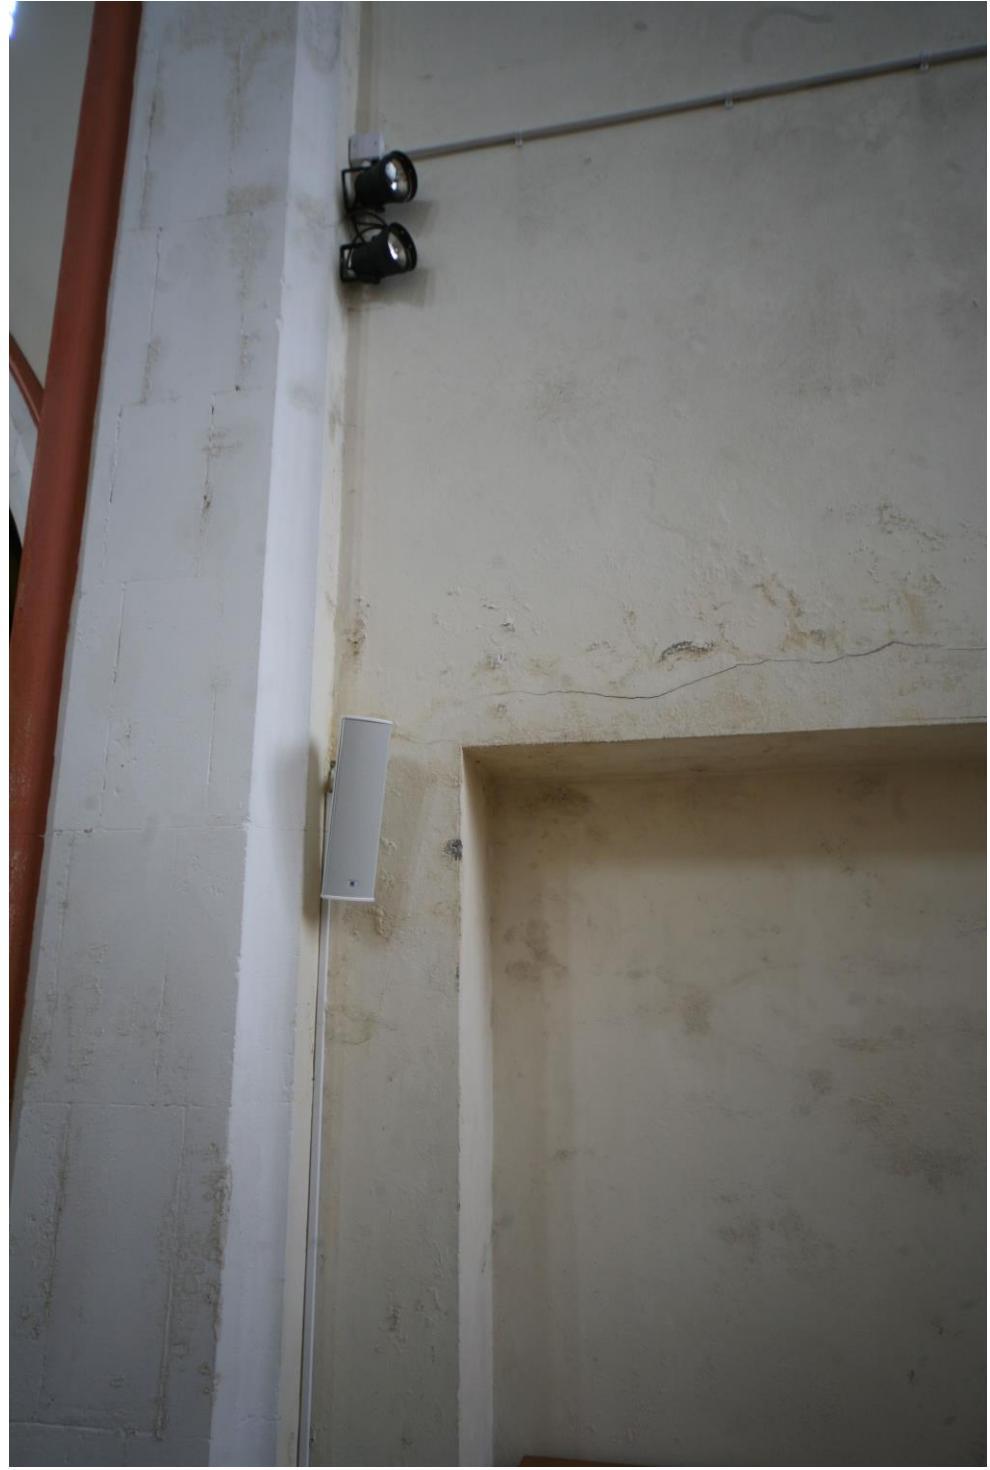
Areas of blown plaster and plaster with salts in (shown by the white salt efflorescence clearly visible) should be removed. The wall allowed to dry and patch repaired with R50. Ultimately when the wall dries the salts should stop moving through the wall however this can be a long slow process. A silane primer can be applied before painting in insil. If the wall remains getting wet then ultimately salts will come through a silane primer. Do not wash off salts as they will just get reabsorbed into the wall instead dry brush and vacuum.

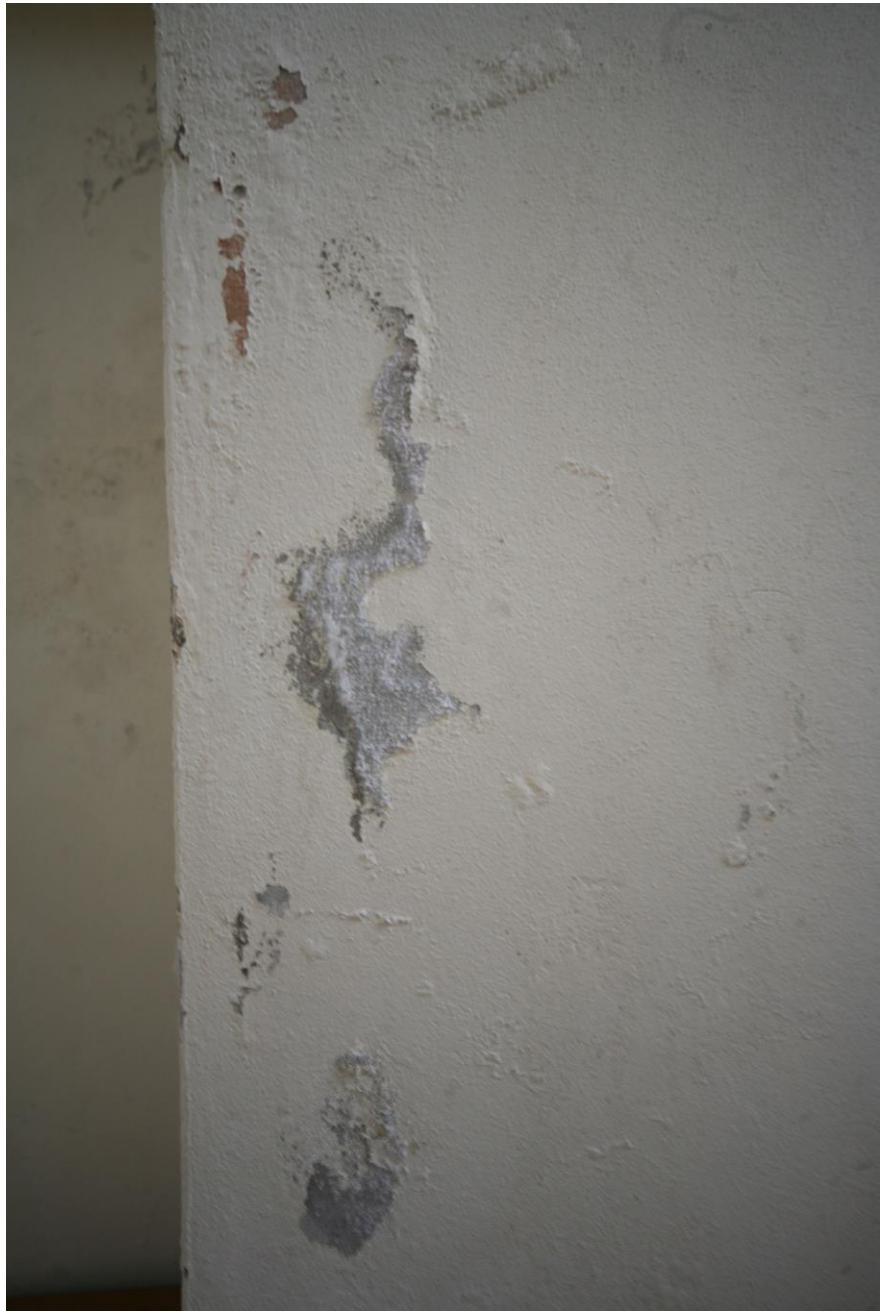
Salts clearly seen on this cement and gypsum plastered wall. Simply painting over in insil will not solve the problem and the insil will come off within a few months.
