Site Visit Report

All Saints Church Ebbw Vale

February 2015

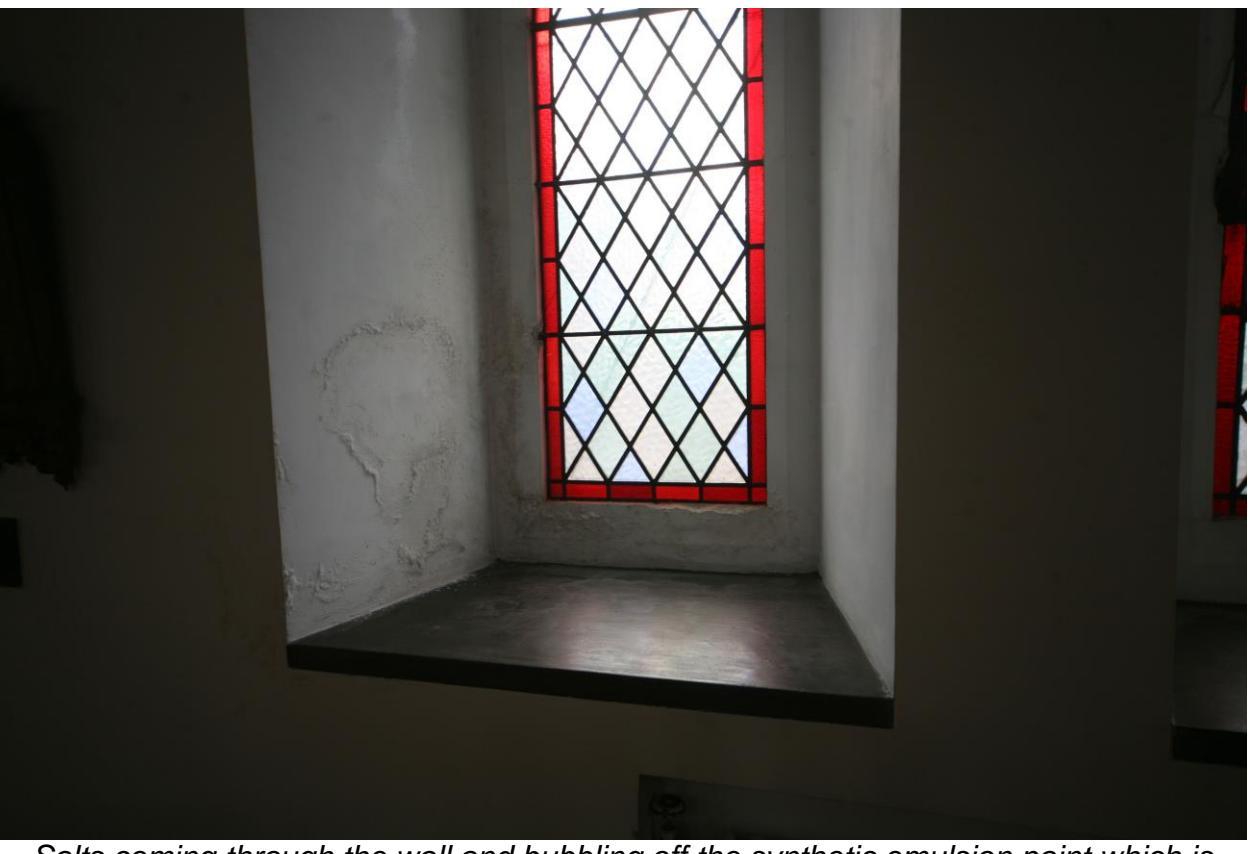
Salts coming through the wall and bubbling off the synthetic emulsion paint which is holding it back. This area should be removed and the wall allowed to dry before patch plastering.

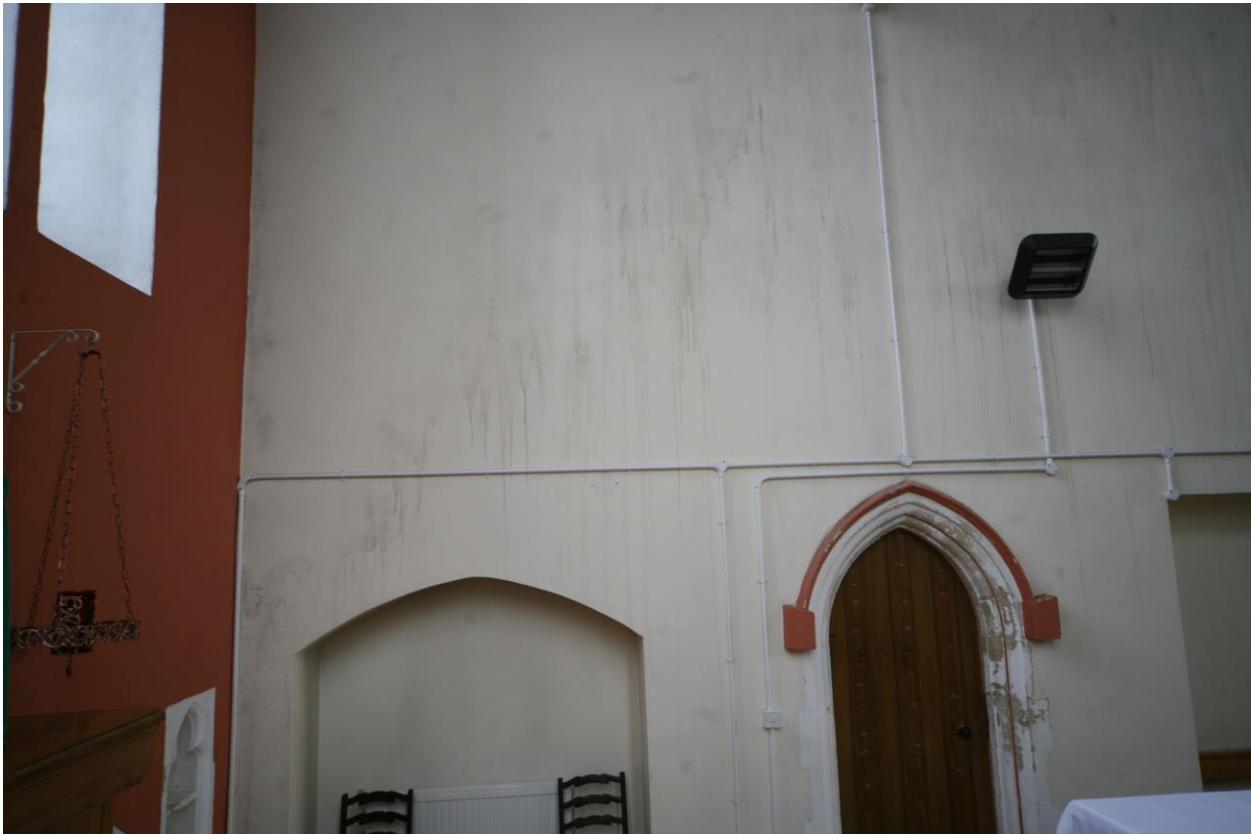
Stains from water running down the walls – these stains should come off with a wash down and sugar soap. Carefully monitor this wall to ensure this does not continue to get wet during heavy rain.

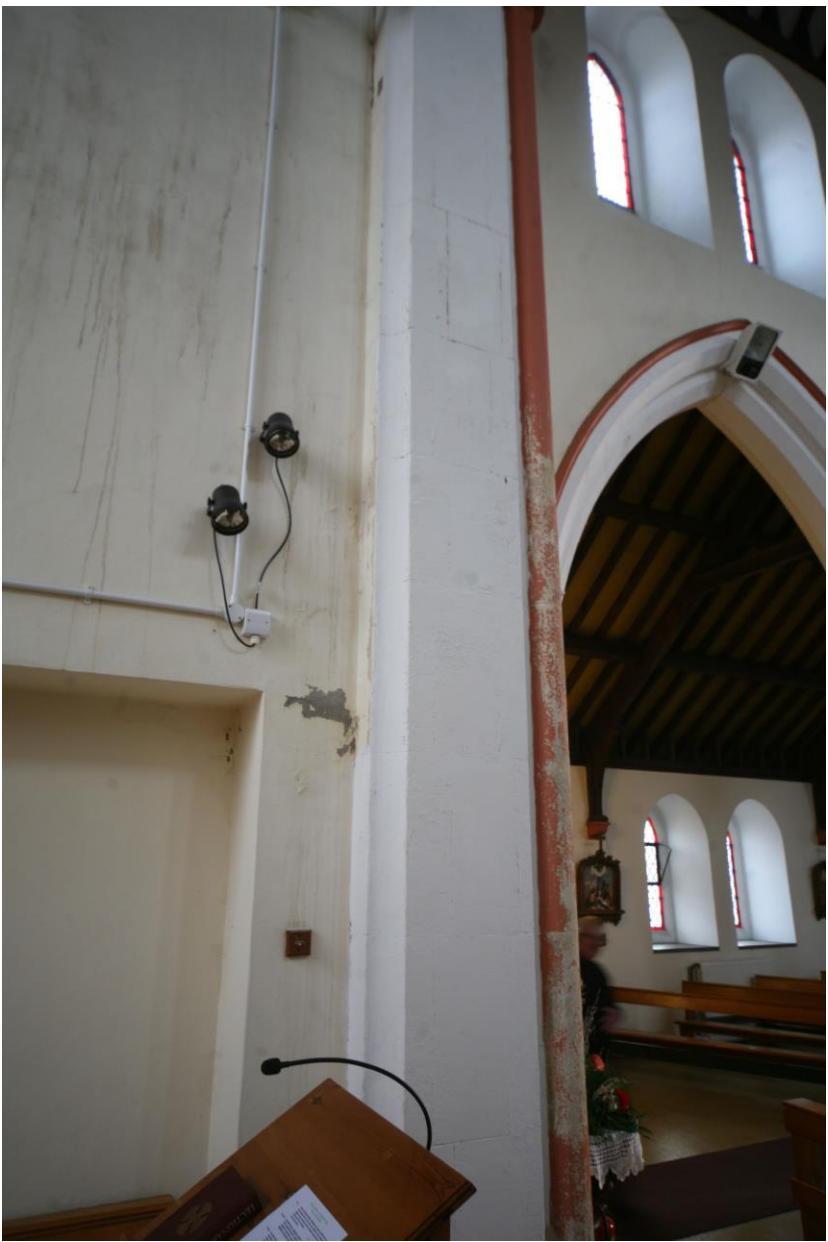
Water staining from running water in the chancel/sanctuary

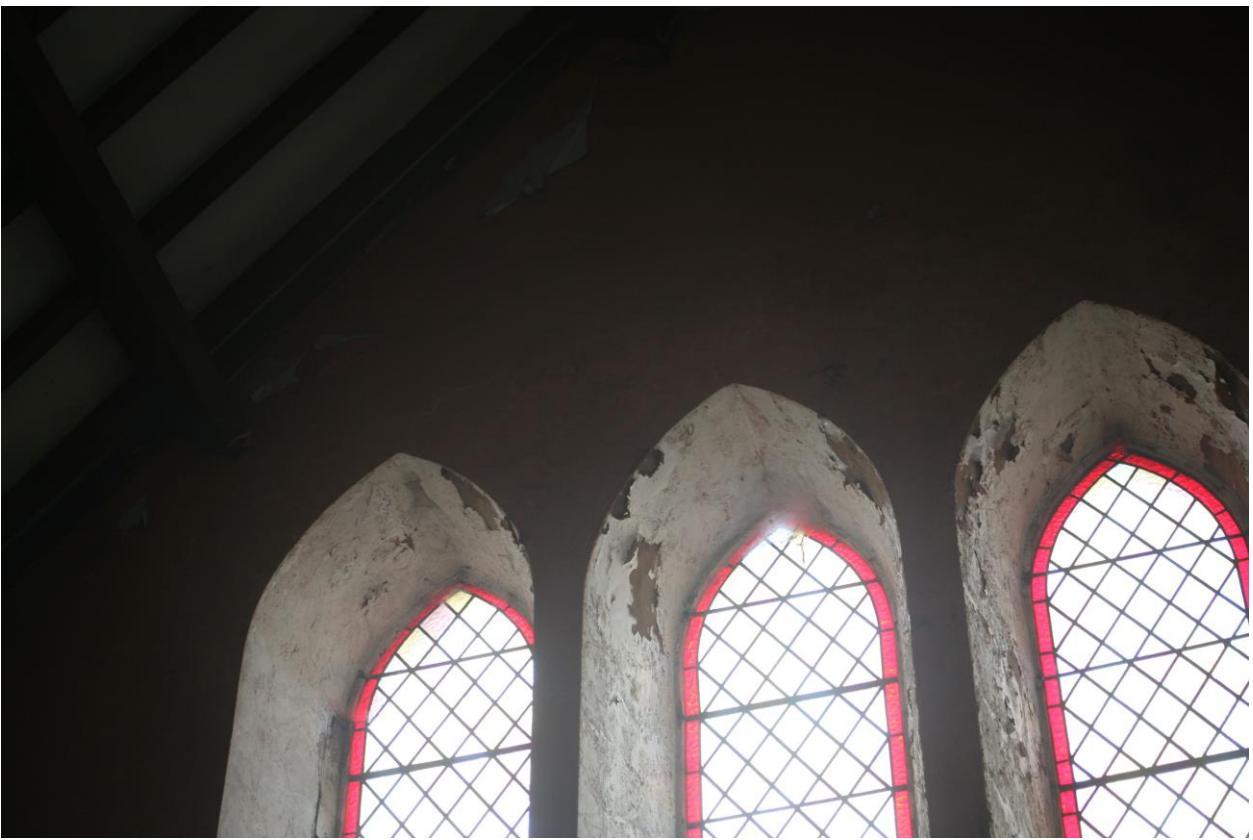
Water ingress on the lancet windows on the west front looking from the balcony. This is likely historic water damage before the gable coping stones were repaired. Remove all loose and flaking paint before applying the insil primer and paint.

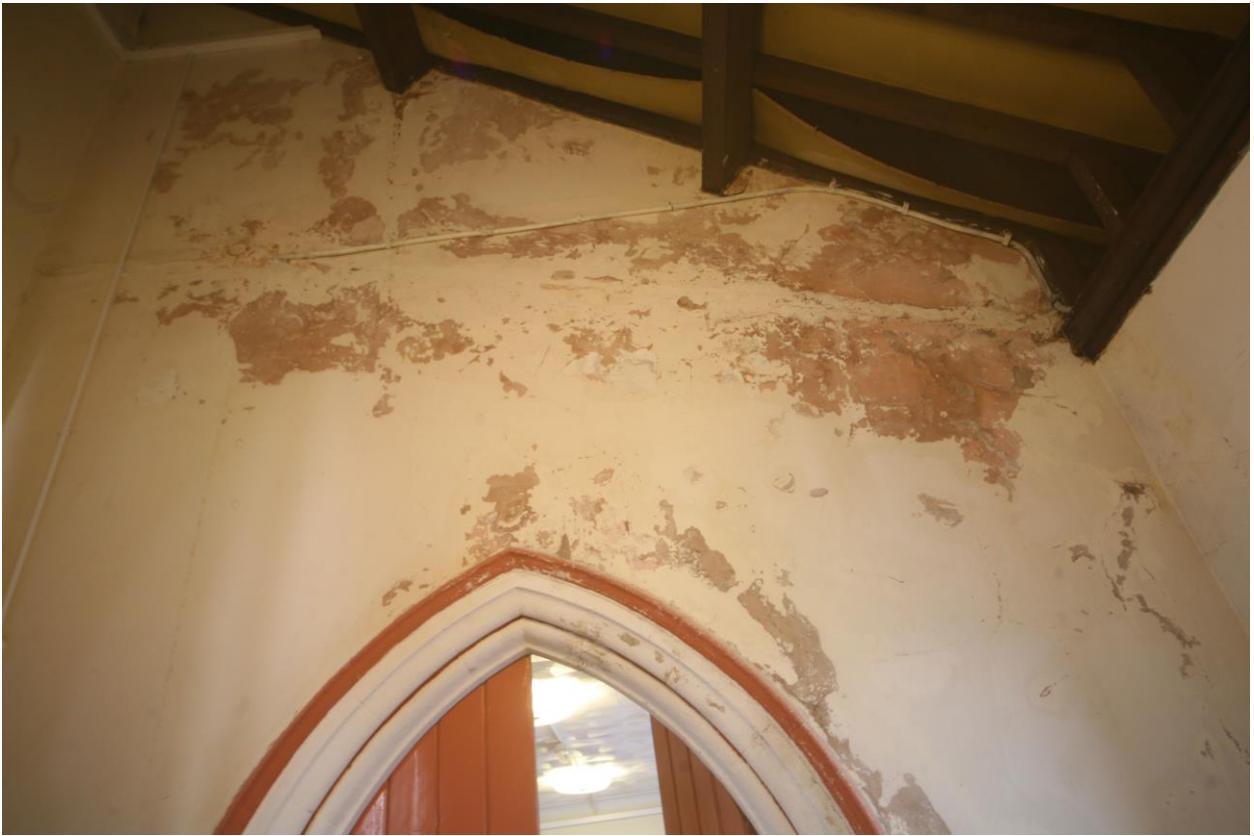
The wall of the vestry from within the side aisle – this has evidently got wet before and the entire wall has been re-plastered with gypsum plaster. This should be removed wholescale and the wall allowed to dry before re-plastering with sand and lime or Ecomortar R50.

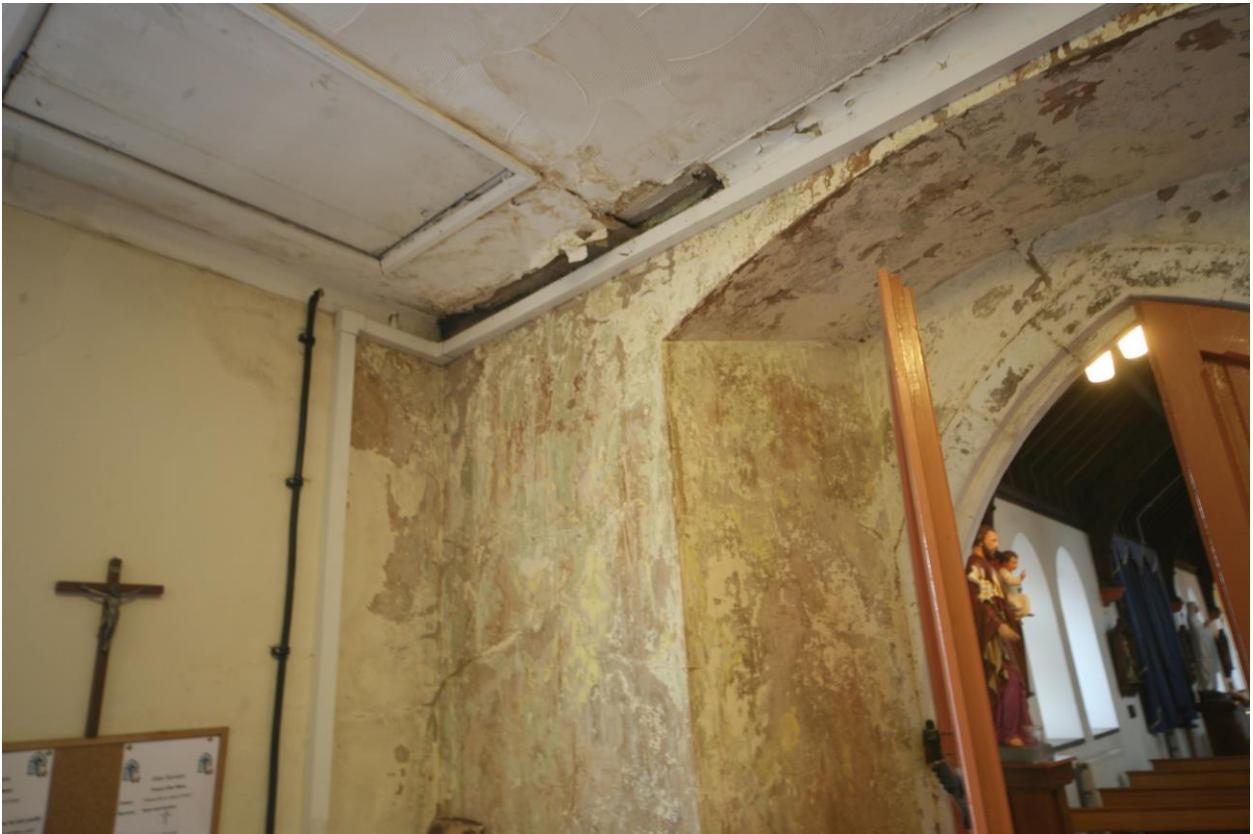
The inside of the vestry – this wall should also be stripped back and allowed to dry before re-plastering with EcoMortarR50. The plaster should be allowed to cure for 4-6 weeks before painting.
